## **SEVENTY BRIDGE ( B3396 )**

### **Structural Appraisal Report**

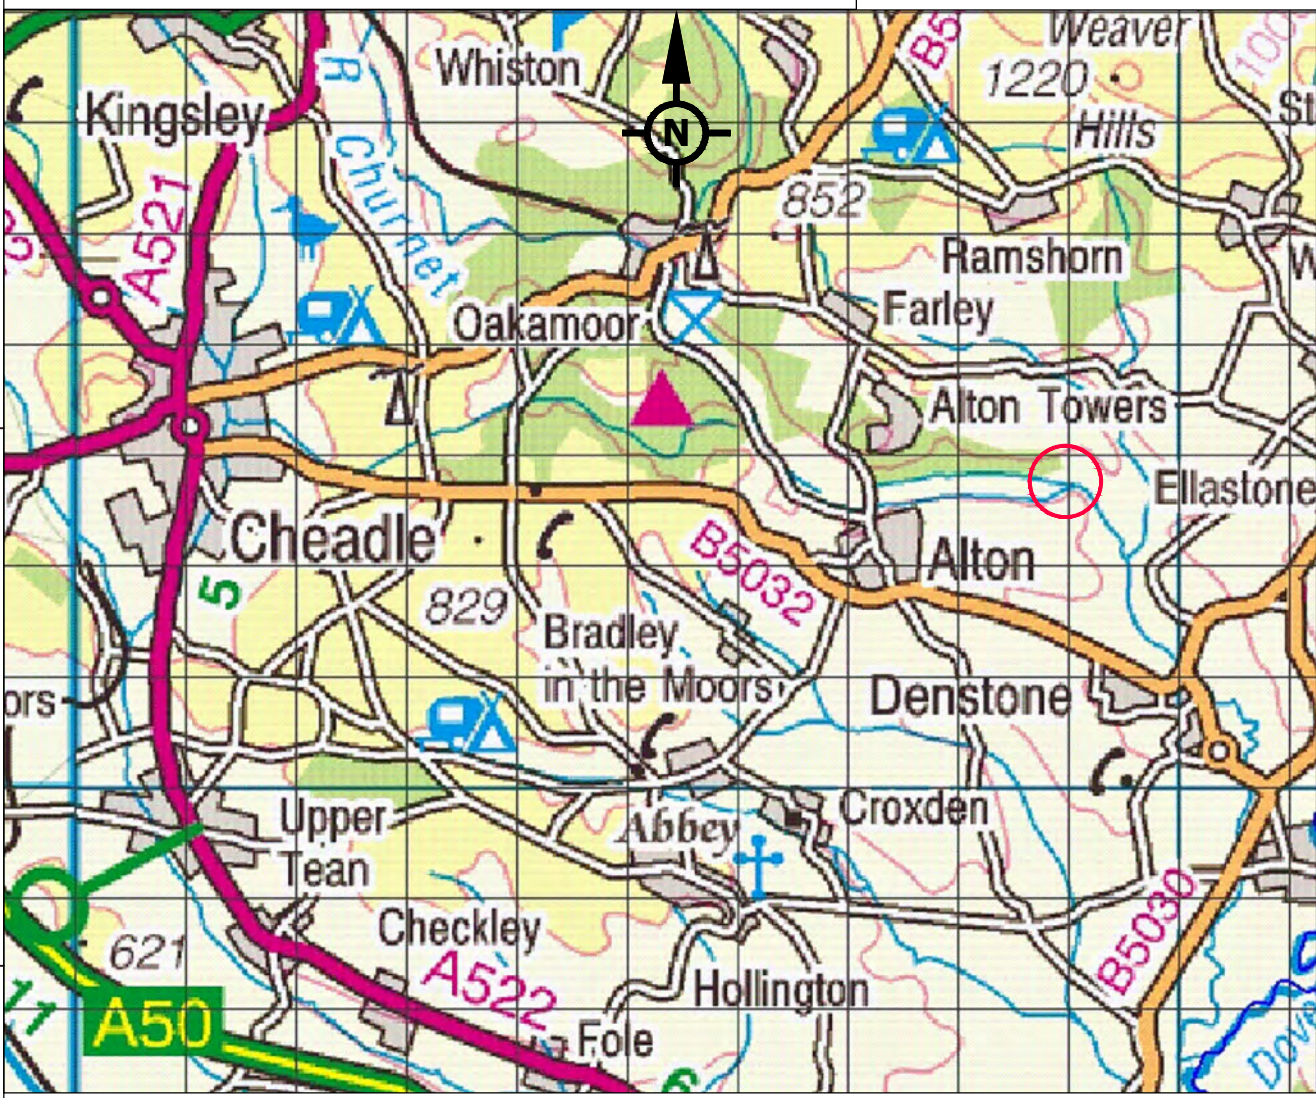
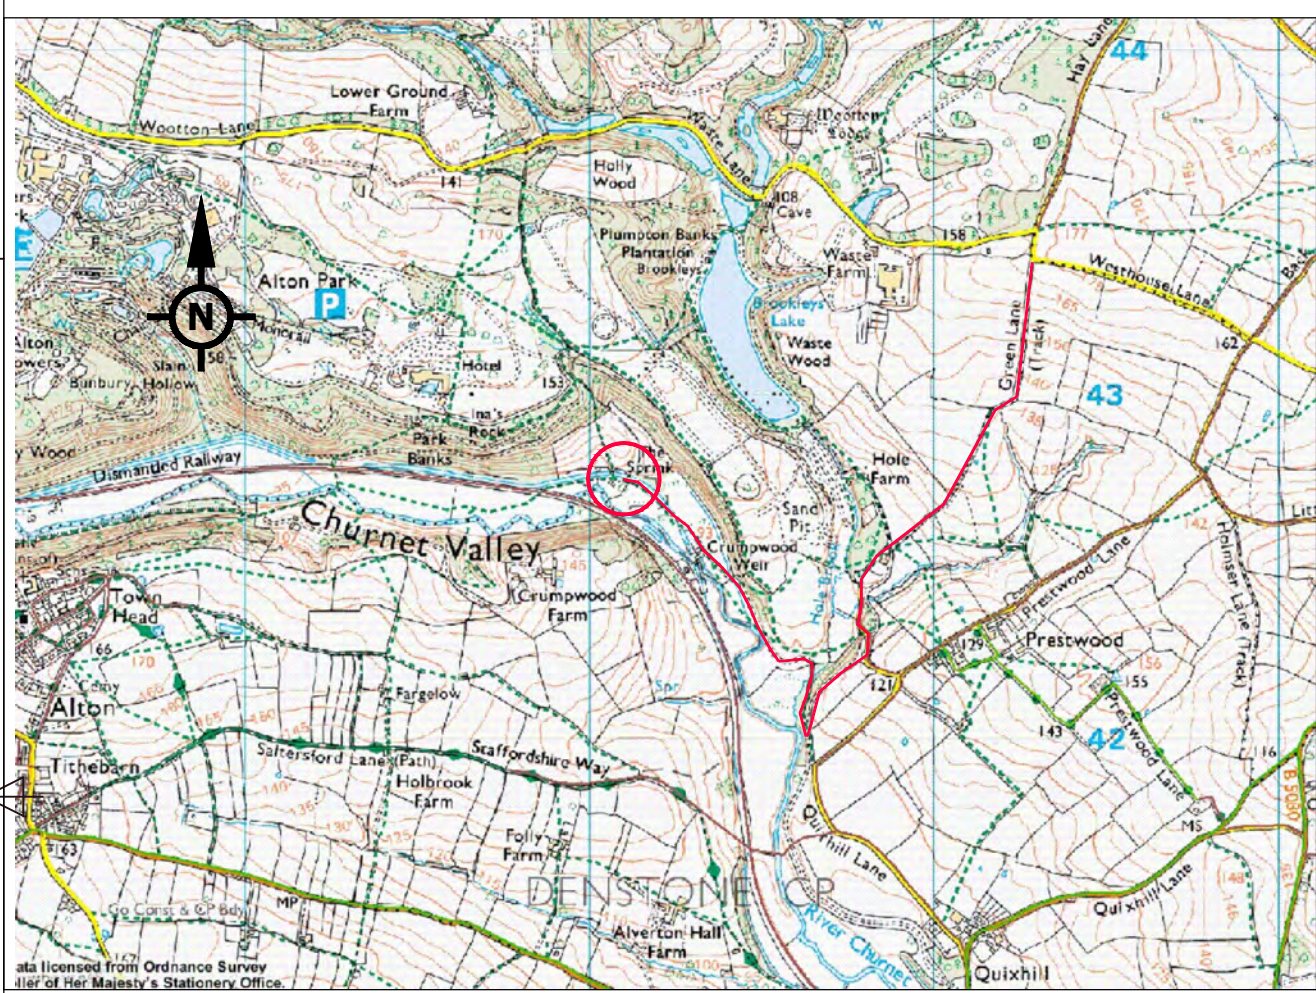
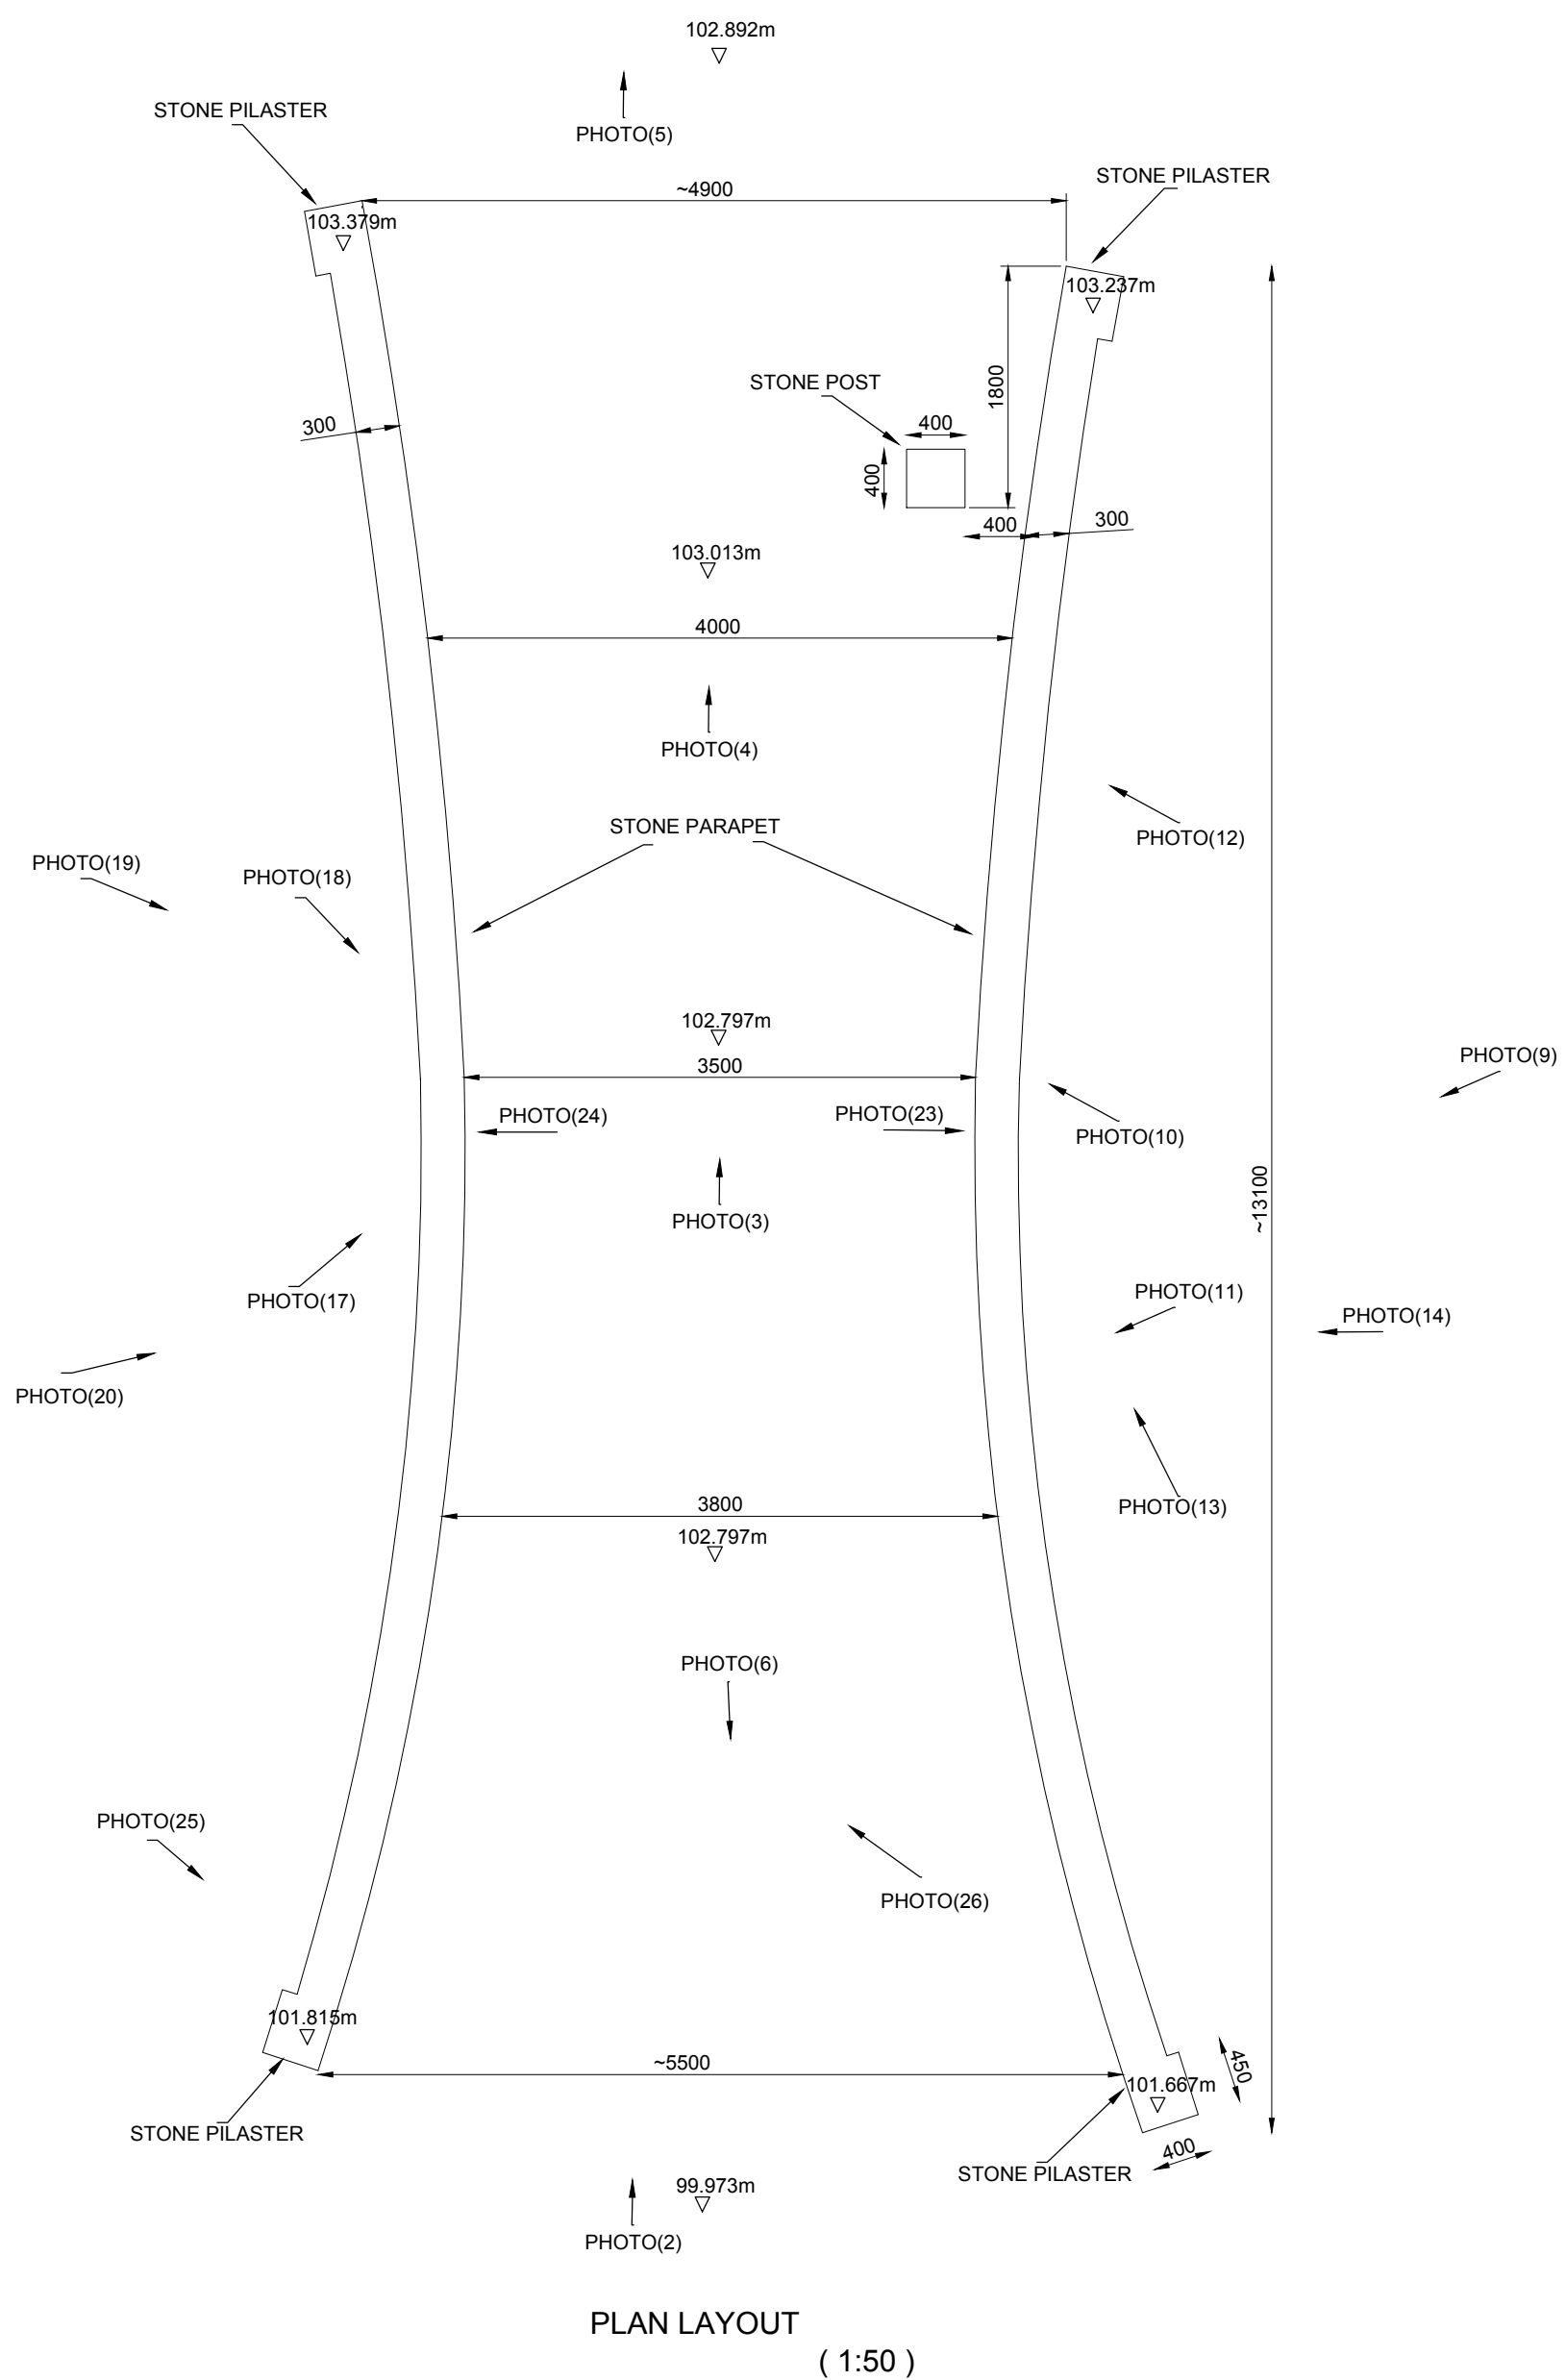
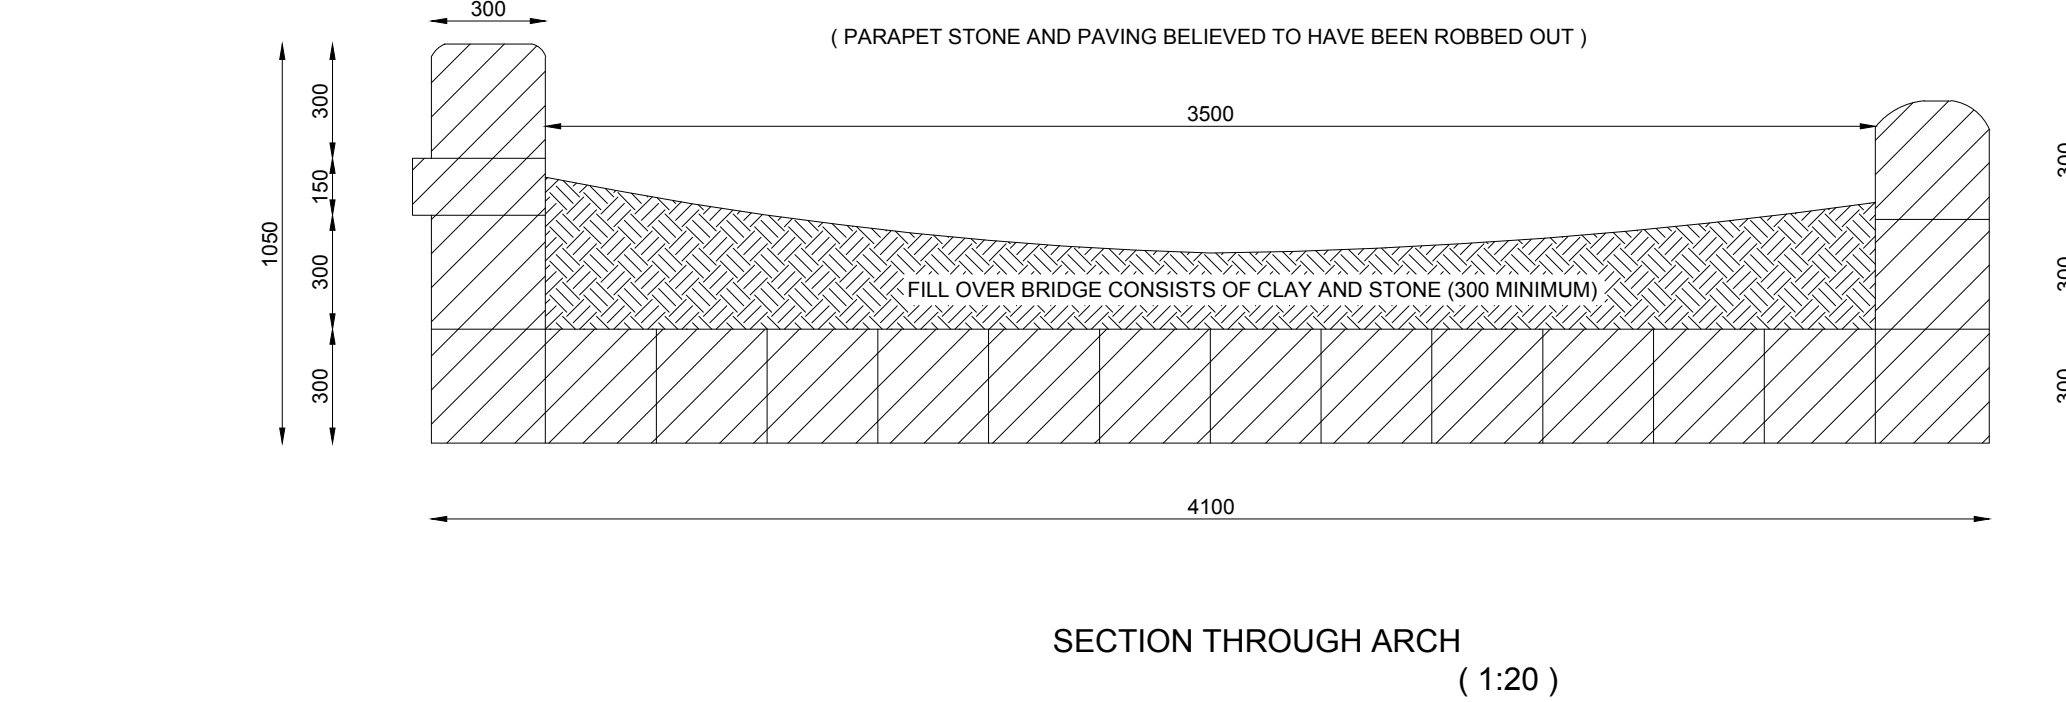
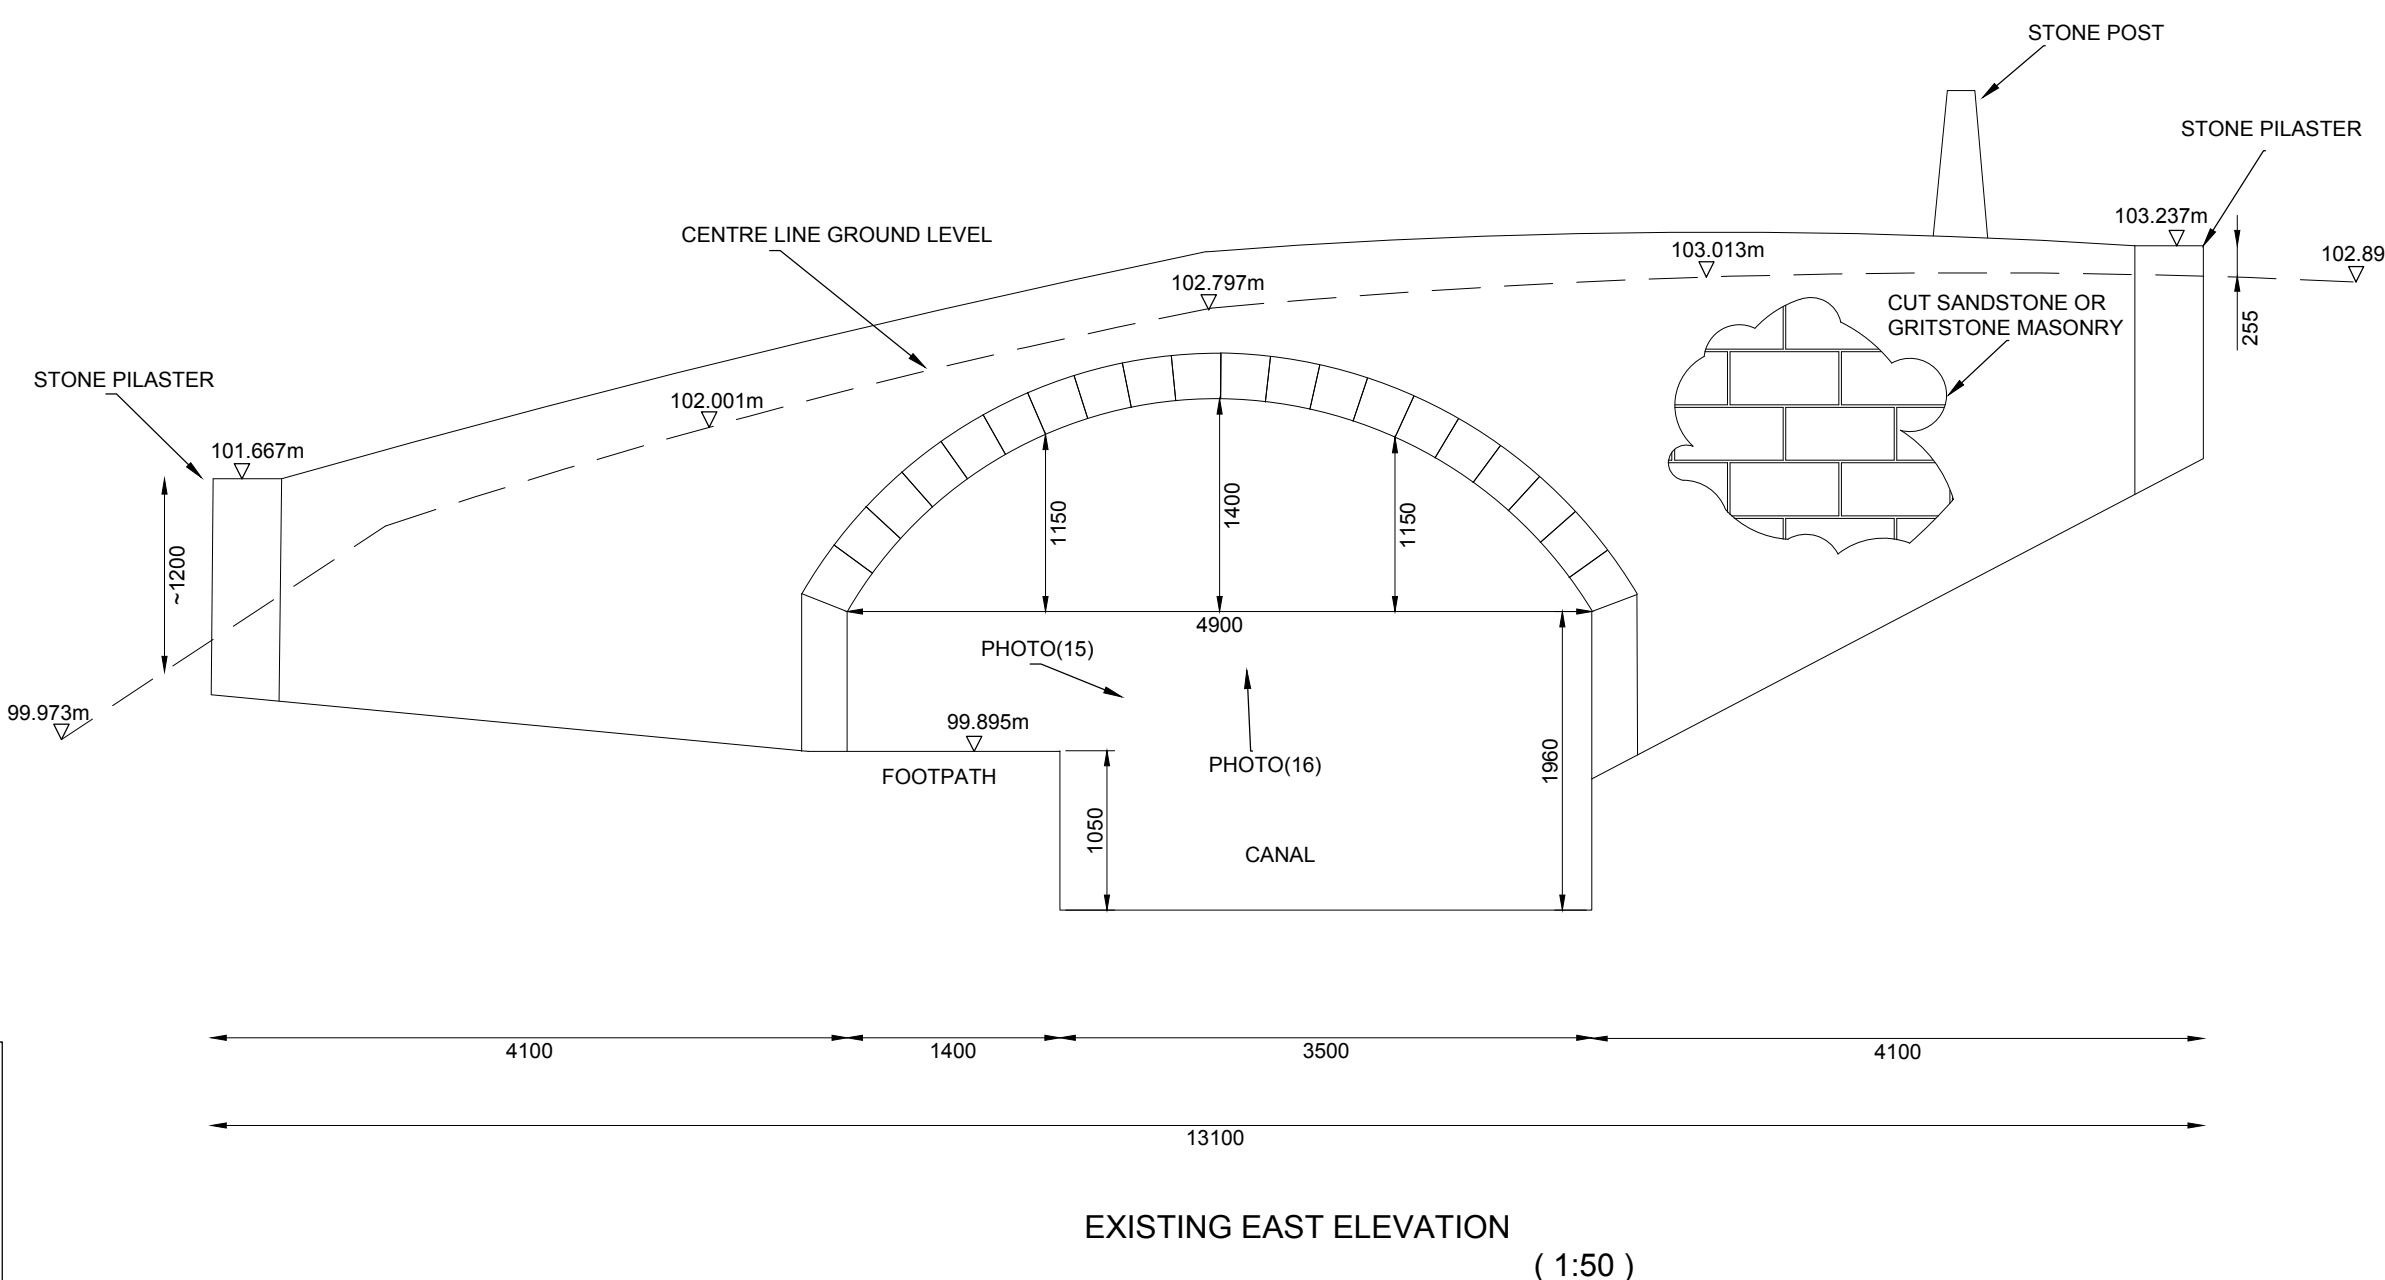
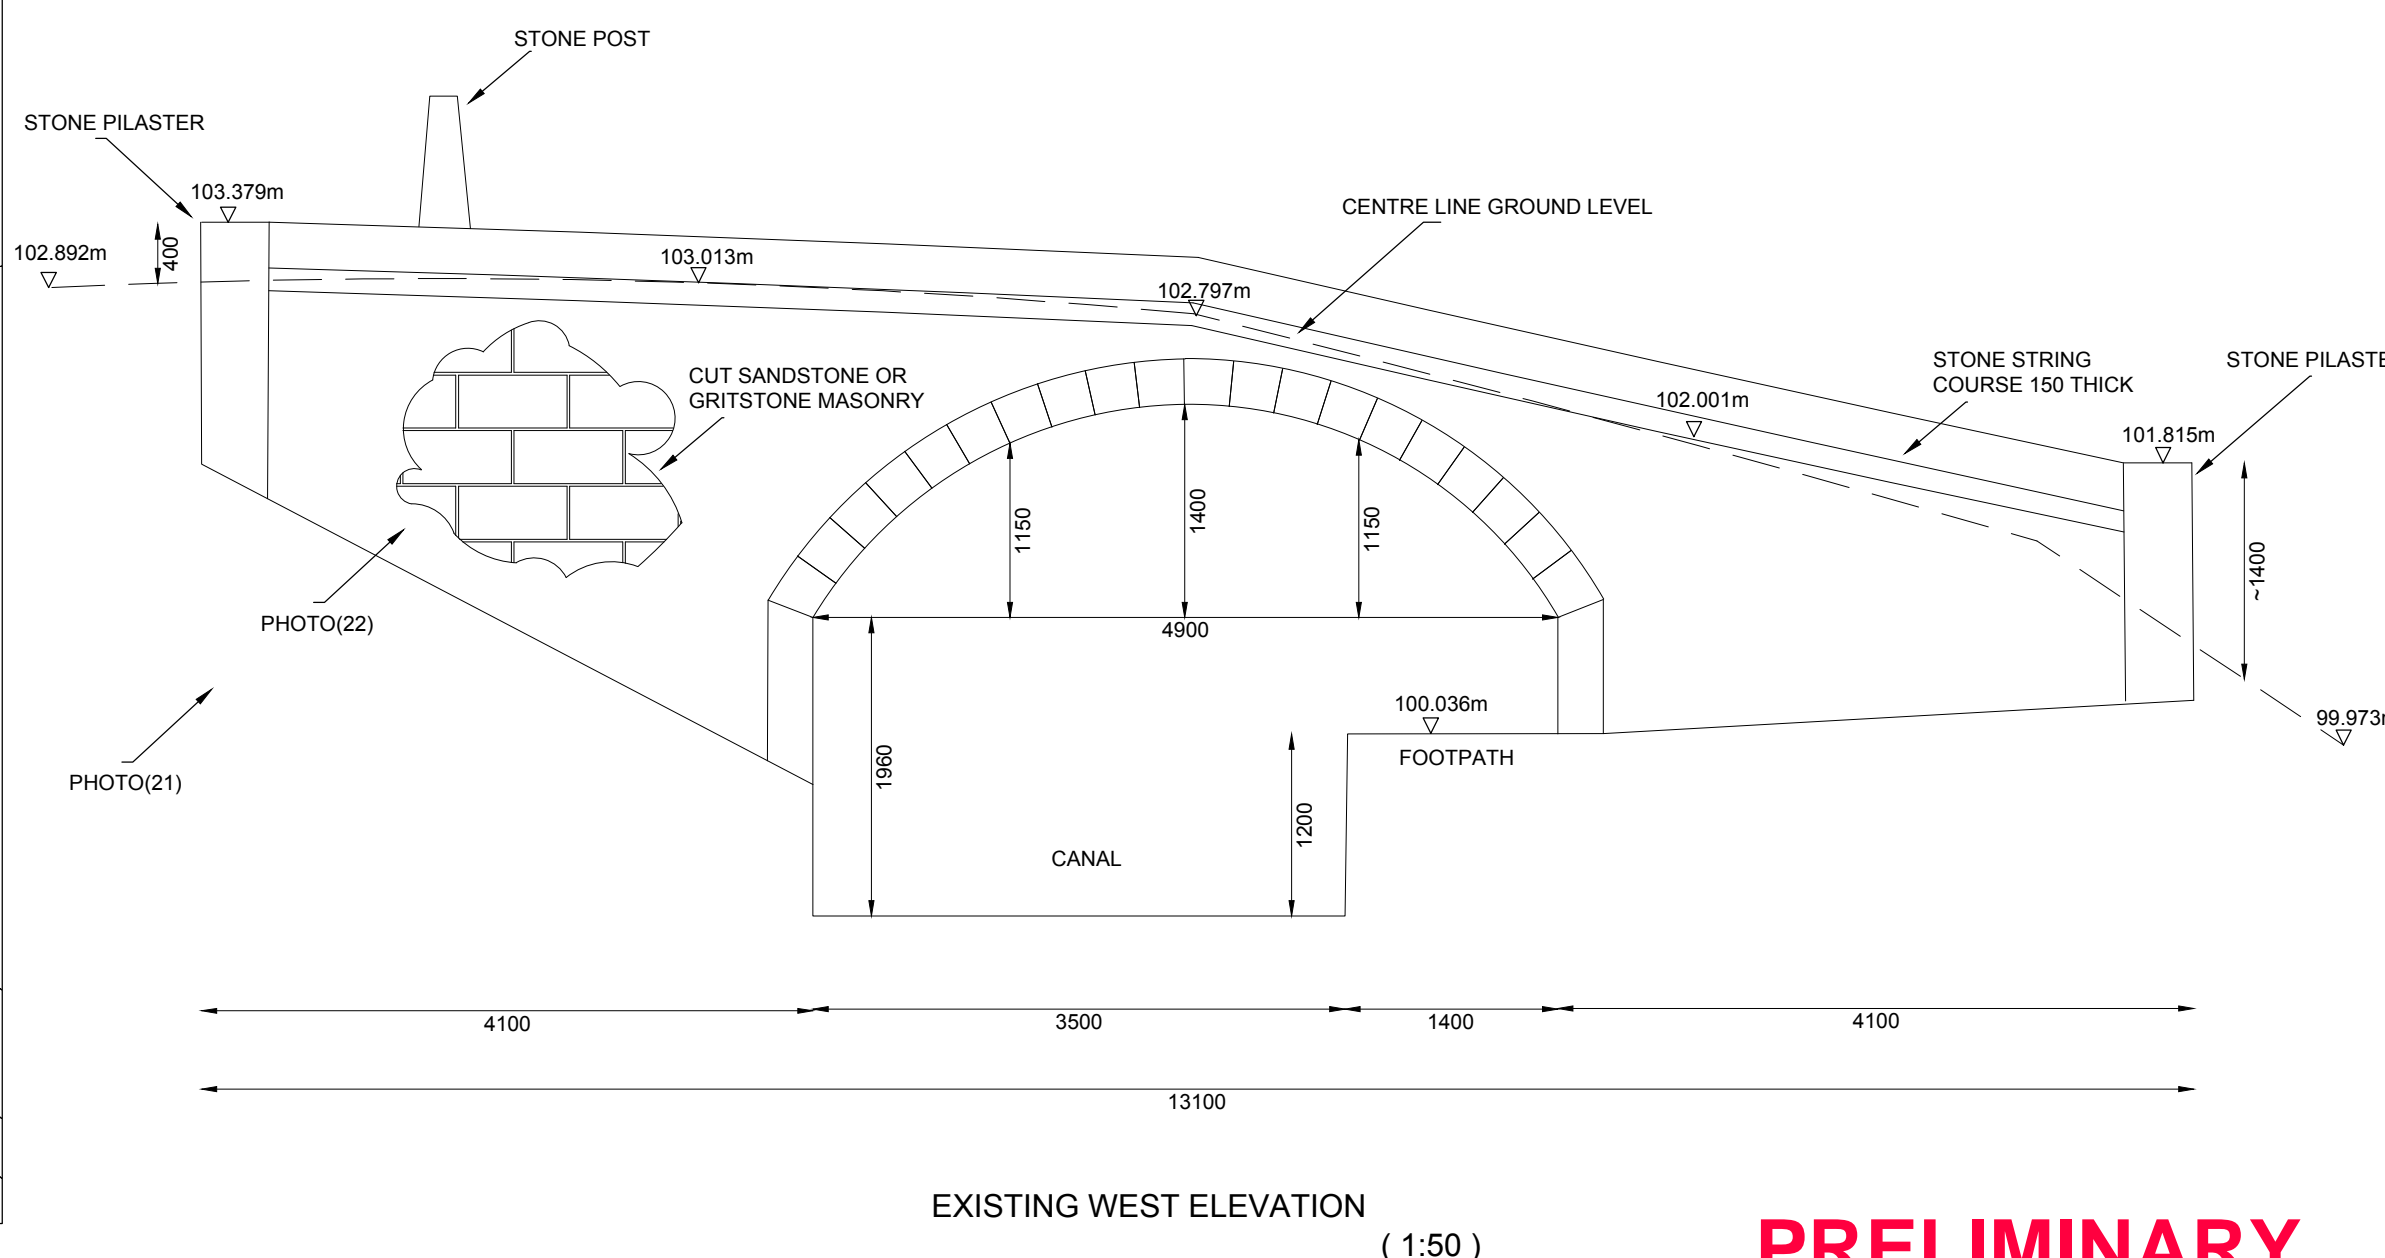
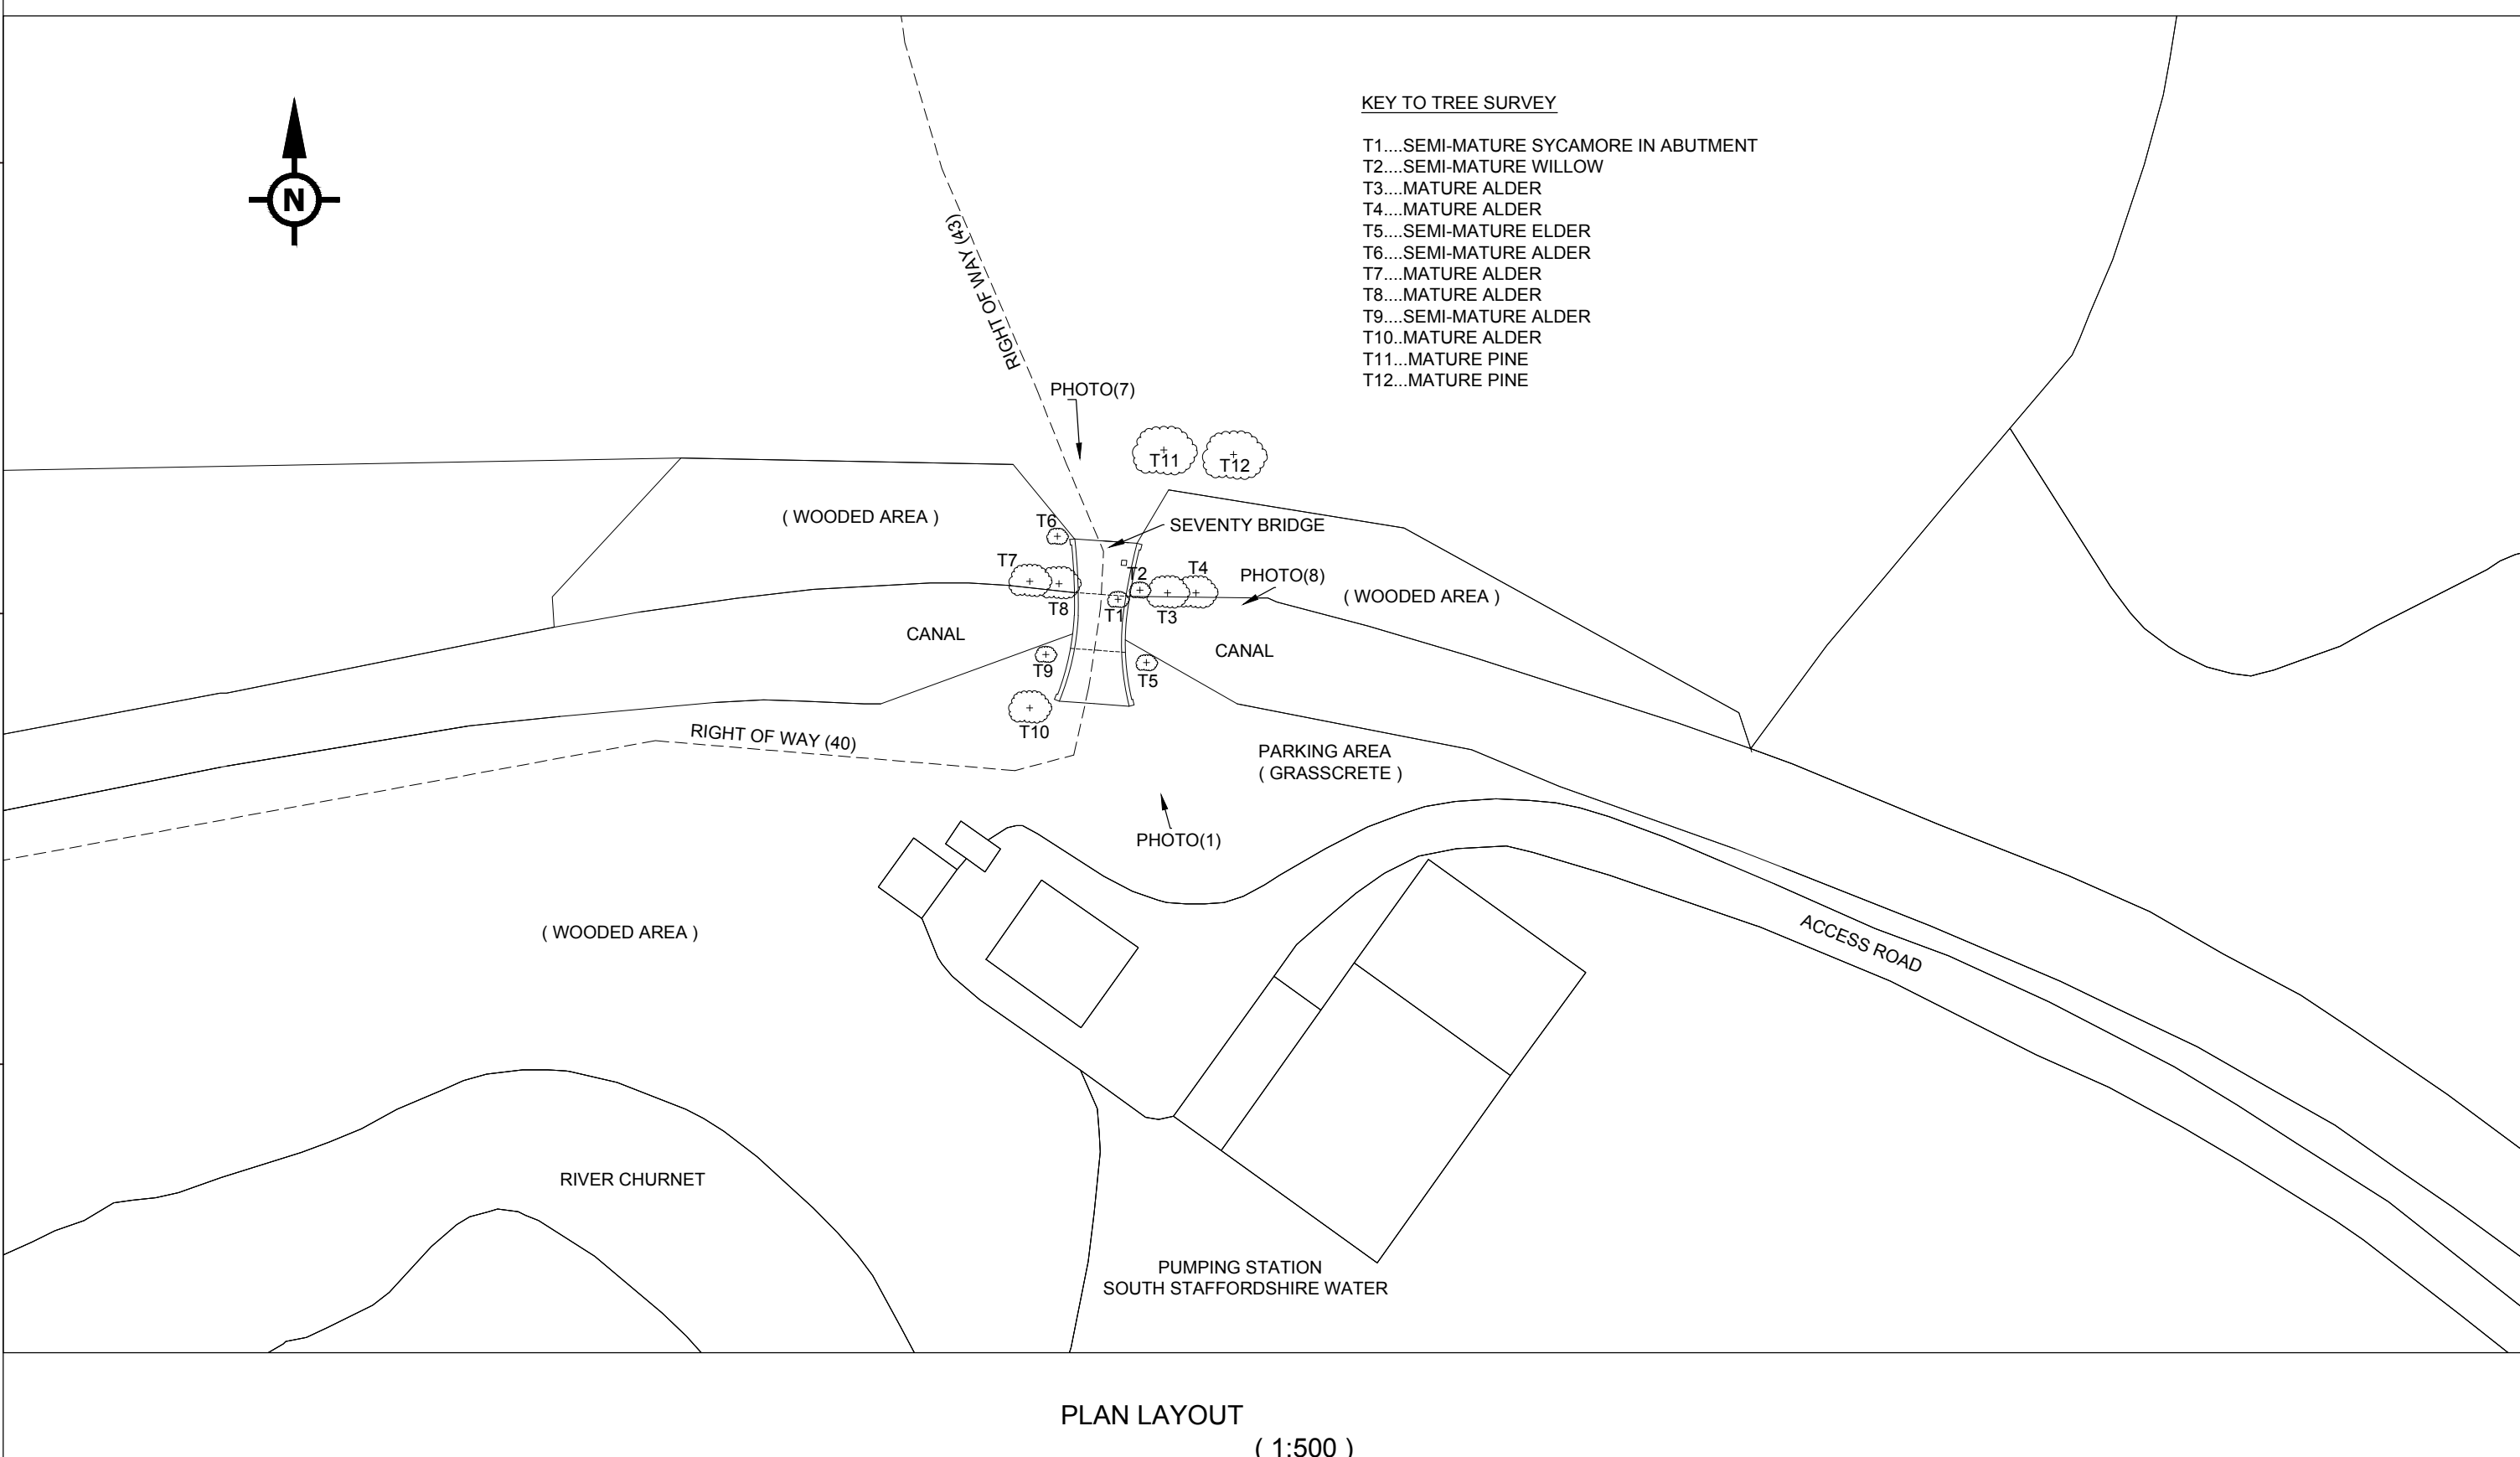
- KEY TO TREE SURVEY**
- T1... SEMI-MATURE SYCAMORE IN ABUTMENT
  - T2... SEMI-MATURE WILLOW
  - T3... MATURE ALDER
  - T4... MATURE ALDER
  - T5... SEMI-MATURE ELDER
  - T6... SEMI-MATURE ALDER
  - T7... MATURE ALDER
  - T8... MATURE ALDER
  - T9... SEMI-MATURE ALDER
  - T10... MATURE ALDER
  - T11... MATURE PINE
  - T12... MATURE PINE

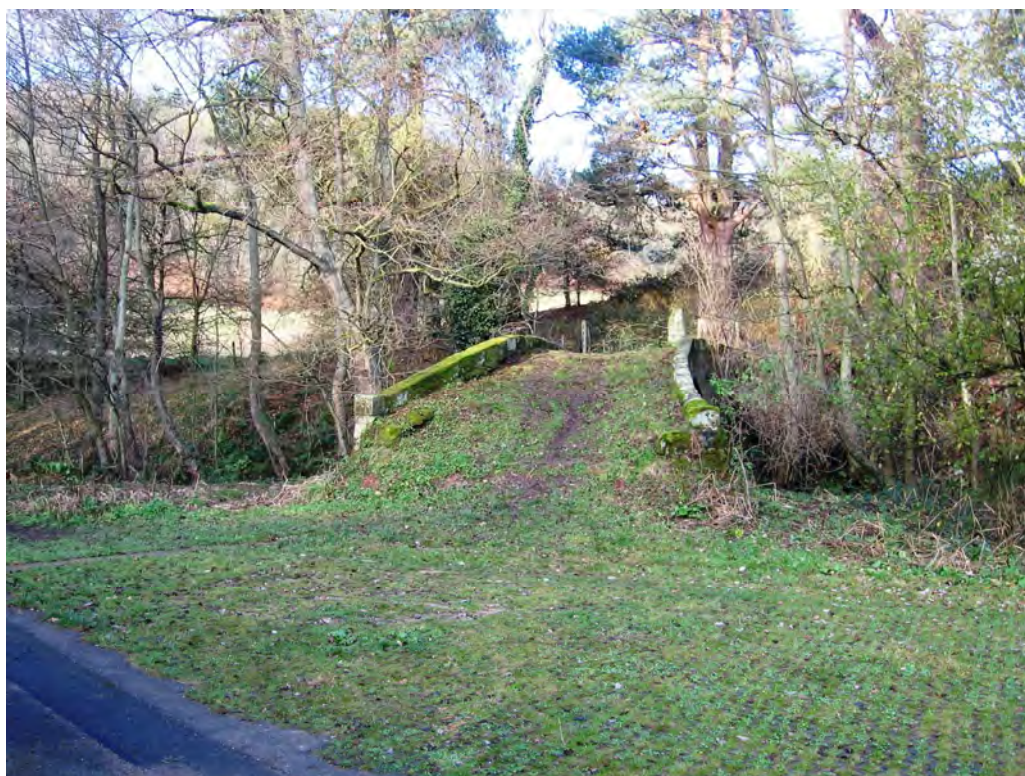
Photo(1): Bridge Deck from Pumping Station.

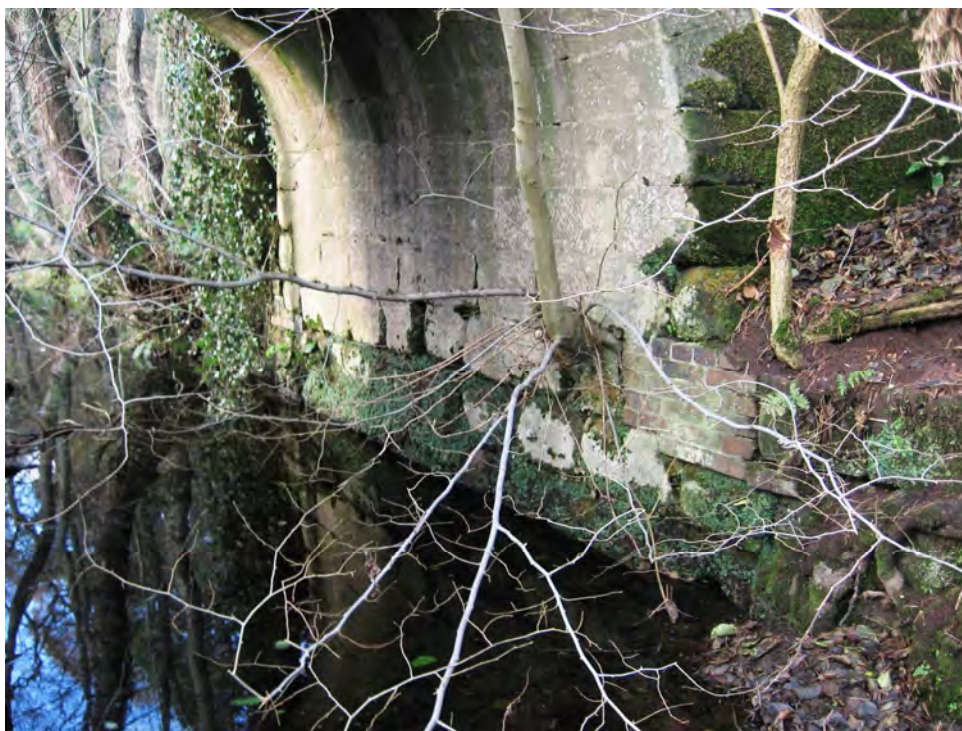
Photo(13): North abutment viewed from east elevation in poor condition.

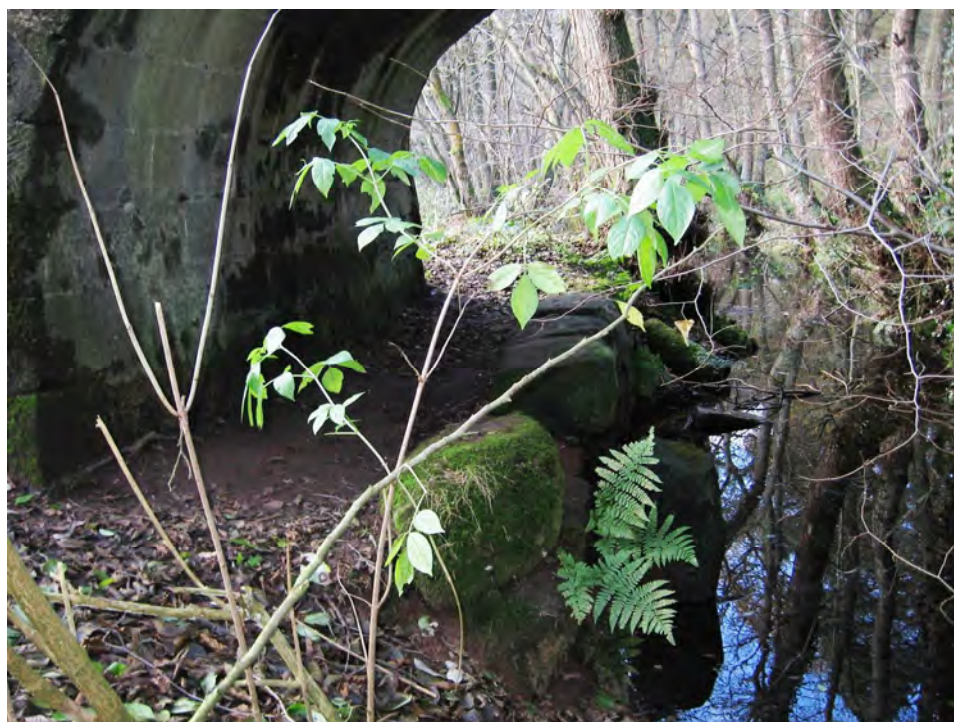
Photo(14): South abutment viewed from east elevation, towpath in poor condition.

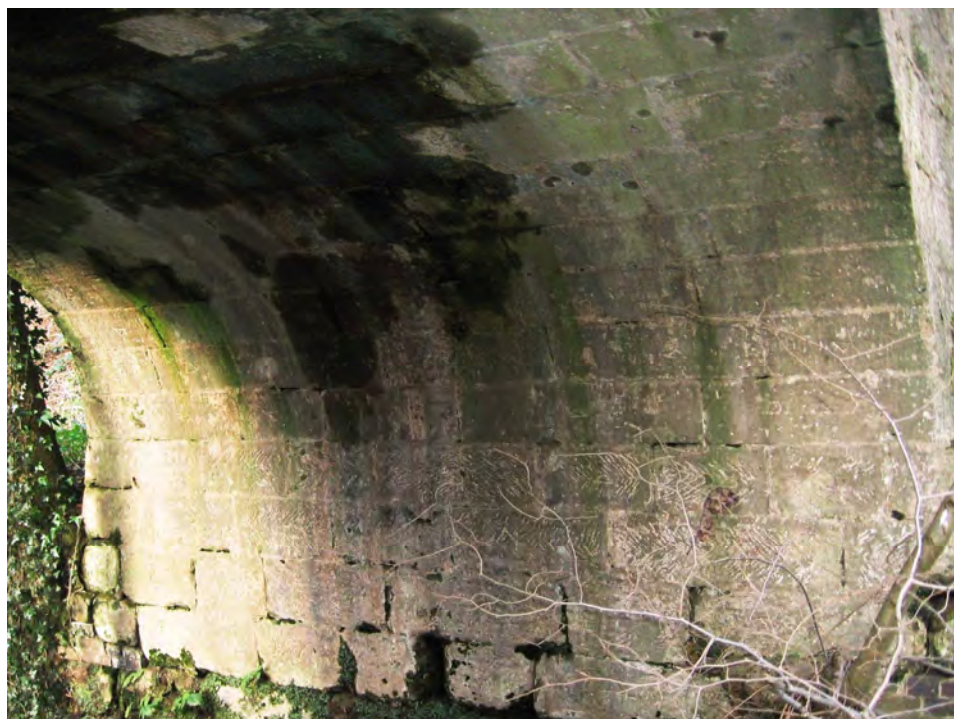
Photo(15): North abutment and arch ring, note water penetration to apex of arch.

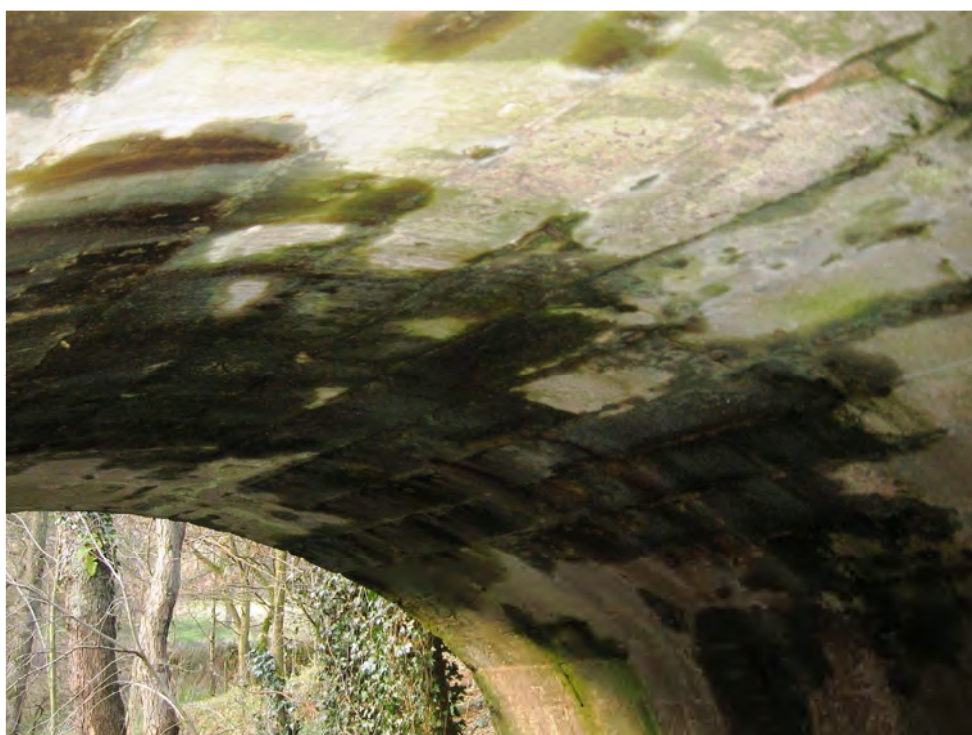
Photo(16): Arch barrel apex in fair condition, except for extensive water penetration.

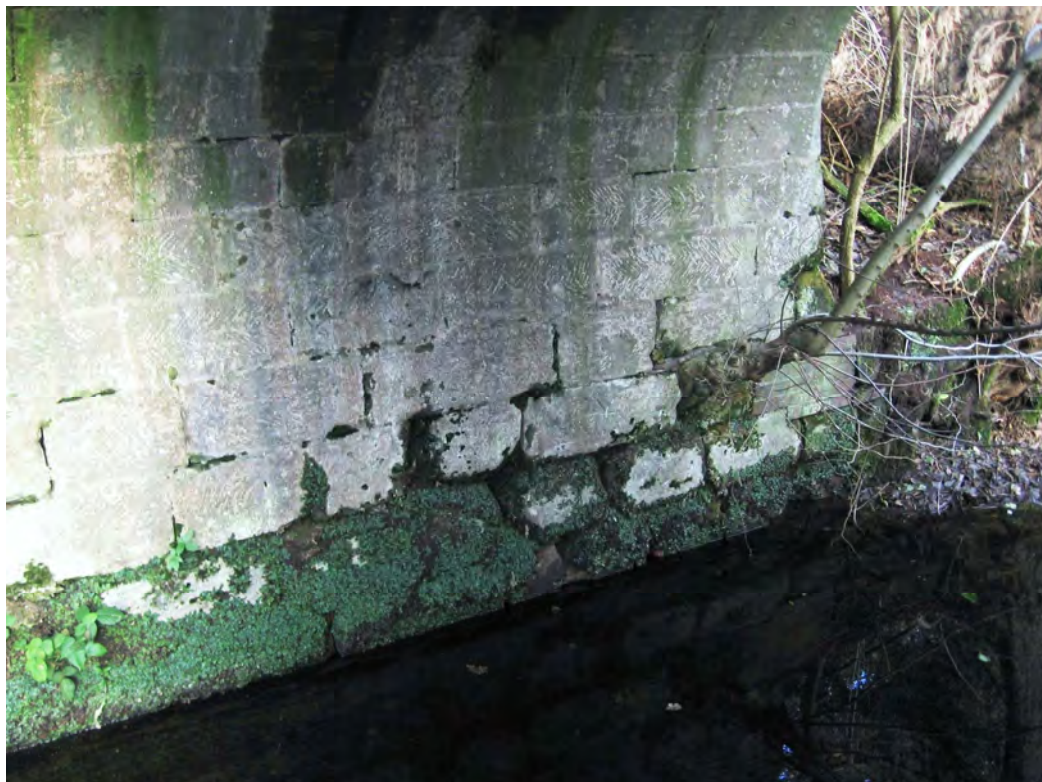
Photo(17): North Abutment from West elevation in poor condition.

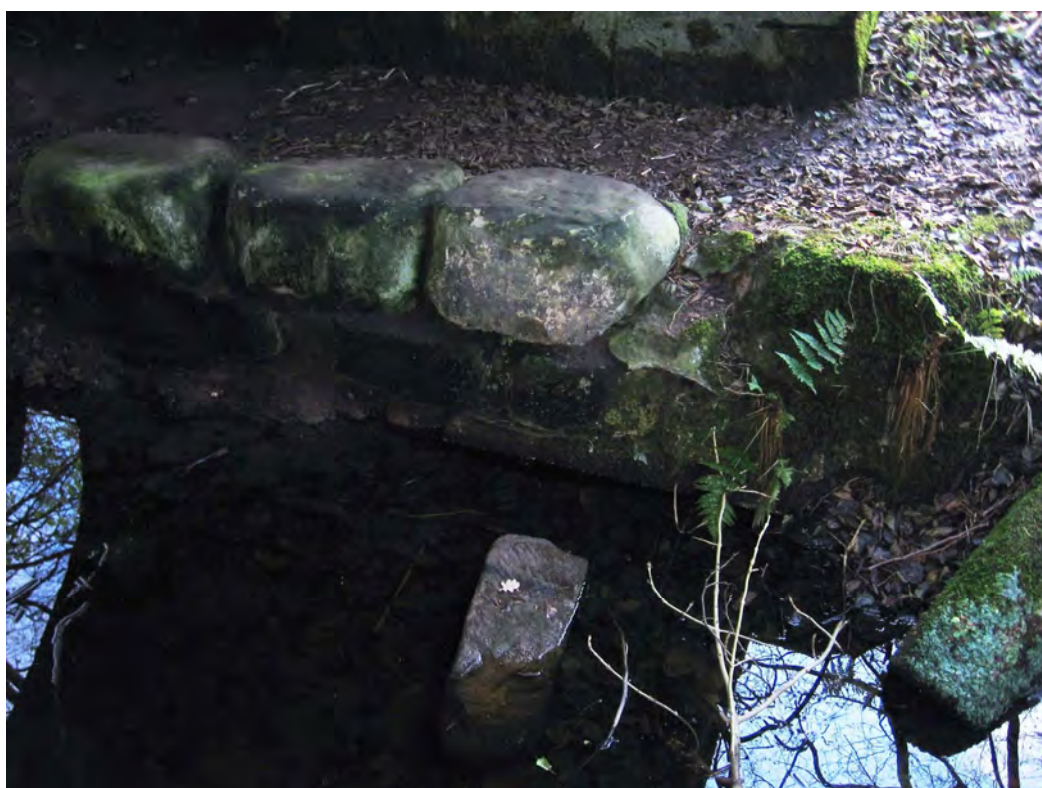
Photo(18): South towpath support wall in poor condition.
