## **SEVENTY BRIDGE ( B3396 )**

### **Structural Appraisal Report**

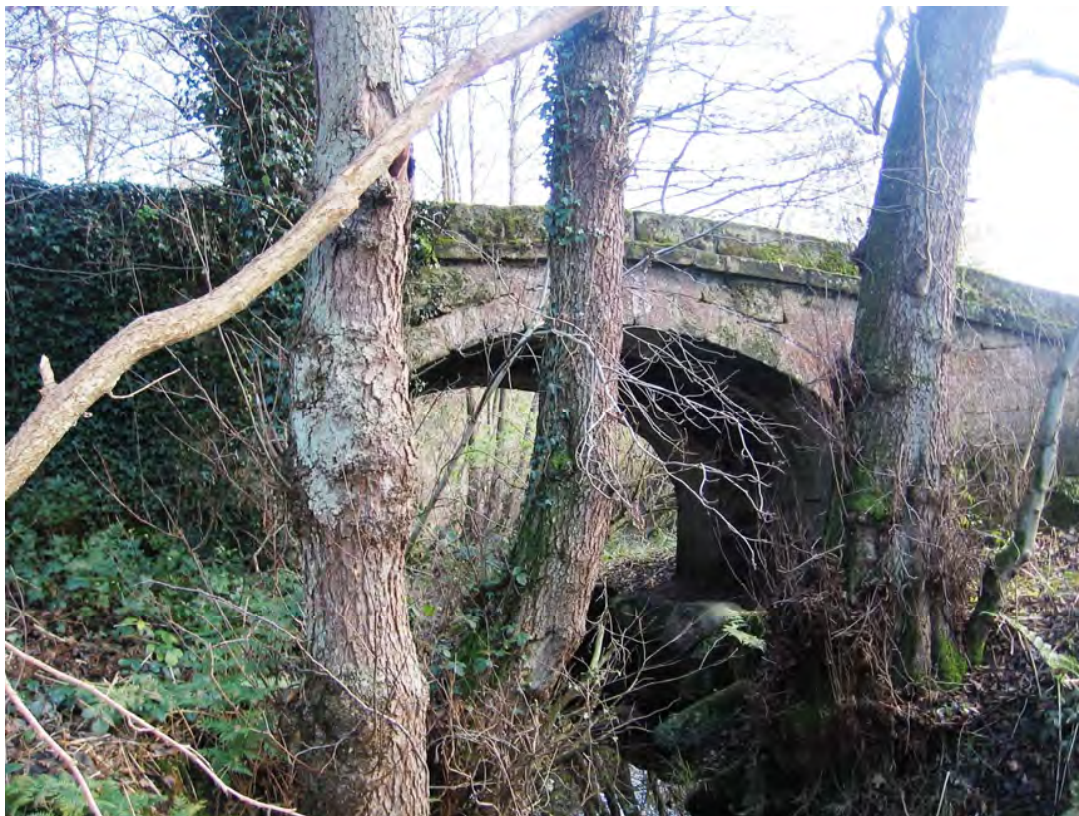
Photo(19): West elevation, heavily overgrown with trees and vegetation.

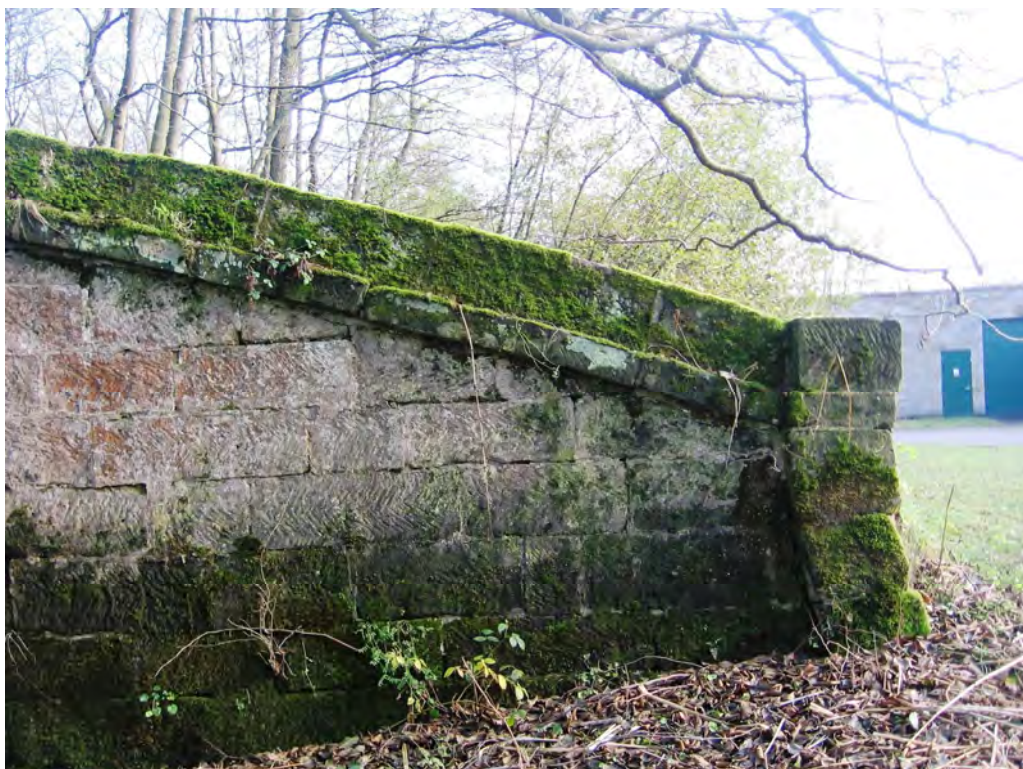
Photo(25): West elevation, south pilaster in fair condition but significant mortar loss.

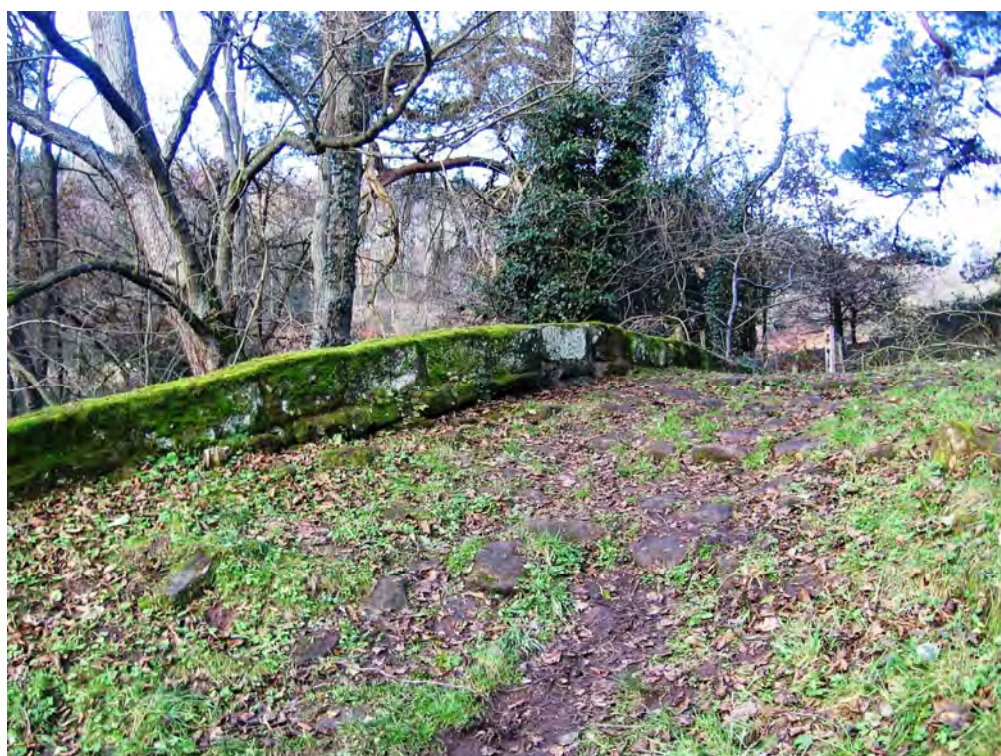
Photo(26): Parapets and surfacing running over the bridge deck in poor condition.
