# Preliminary Ecological Appraisal

Uttoxeter Canal Bridge 70 (B3396)  
Crumpwood, nr. Denstone, Staffordshire

Final Report

Report no. P68.T56.12  
3<sup>rd</sup> September 2012

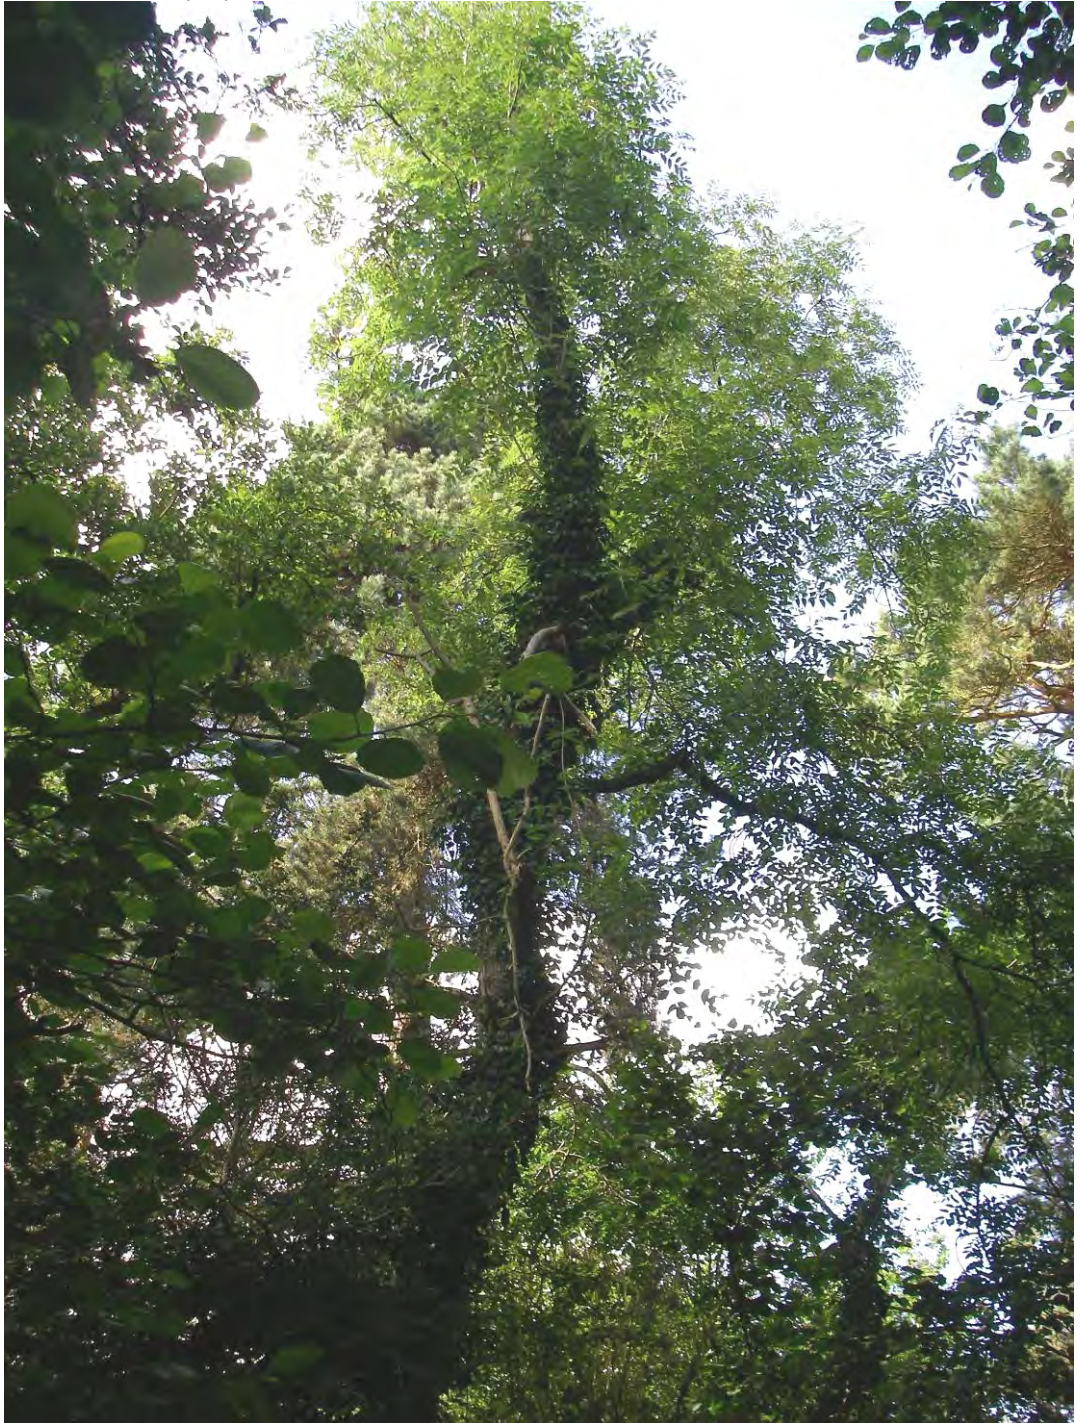
T8, a mature ash (*Fraxinus excelsior*) circled in red, is heavily ivy clad and shows some signs of deterioration toward the canopy. There is potential that the ivy may be hiding features that have potential to be used by roosting bats, and the ivy itself may provide a transitory roosting location. Plate 3.1 shows T8.

*Plate 3.1: Heavily ivy clad ash tree T8*

- 5.1 Summer bat roost emergence / re-entry surveys and winter hibernation surveys are recommended prior to the commencement of any repair works to the bridge. The surveys must be carried out in accordance with Bat Surveys, Good Practice Guidelines following guidelines for structures with moderate roost potential.
- 5.2 Summer bat roost emergence / re-entry surveys are recommended prior to the removal of the mature ash tree T8 as defined in figure 3.2 (if required). The surveys must be carried out in accordance with Bat Surveys, Good Practice Guidelines following guidelines for trees with moderate roost potential.

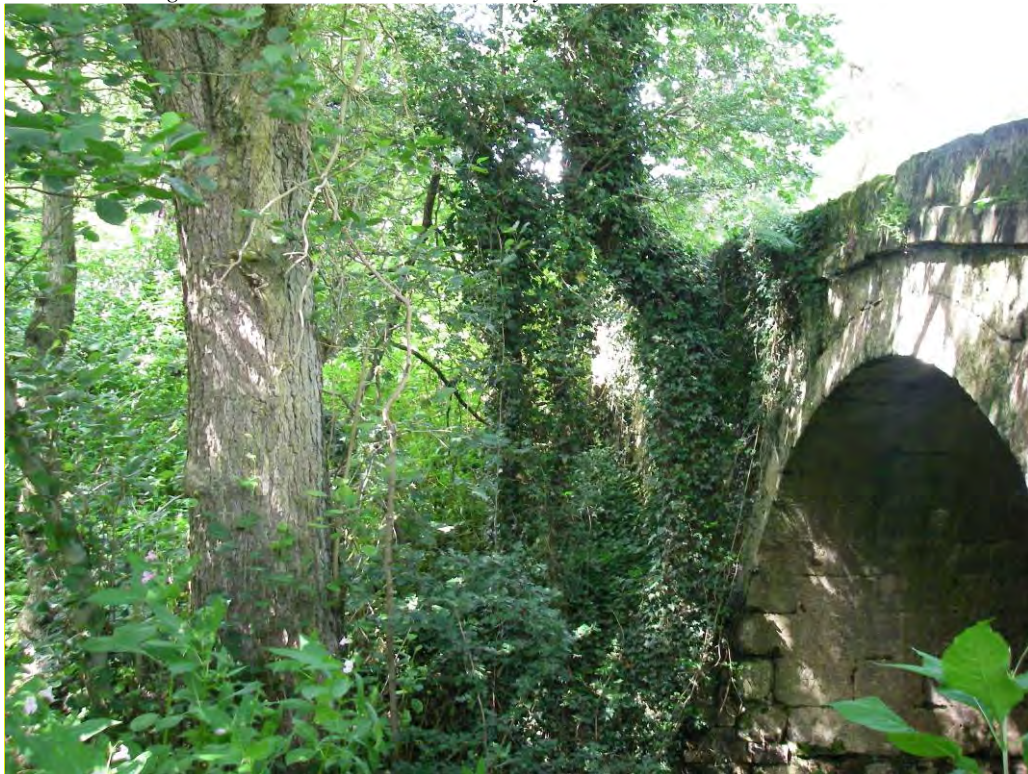
*Plate B.1: Bridge arch and elevations sheltered by trees*

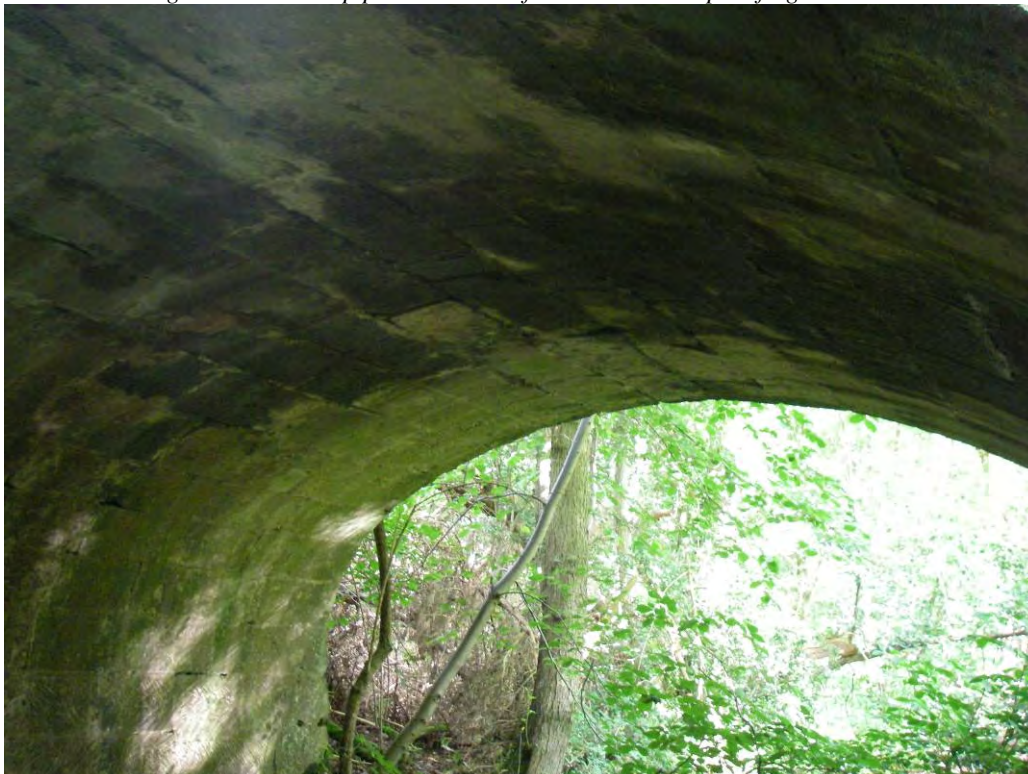
The bridge arch and elevations contain a multitude of crevices, mainly due to missing mortar joints. The waterproofing of the bridge deck has failed, and this has led to large areas of the arch becoming very damp. Damp crevices are generally unattractive as summer roosts for bats. However, a small number of crevices under the bridge and on the elevations appear dry and therefore suitable for roosting.

*Plate B.2: Bridge arch has damp patches due to failed deck waterproofing*

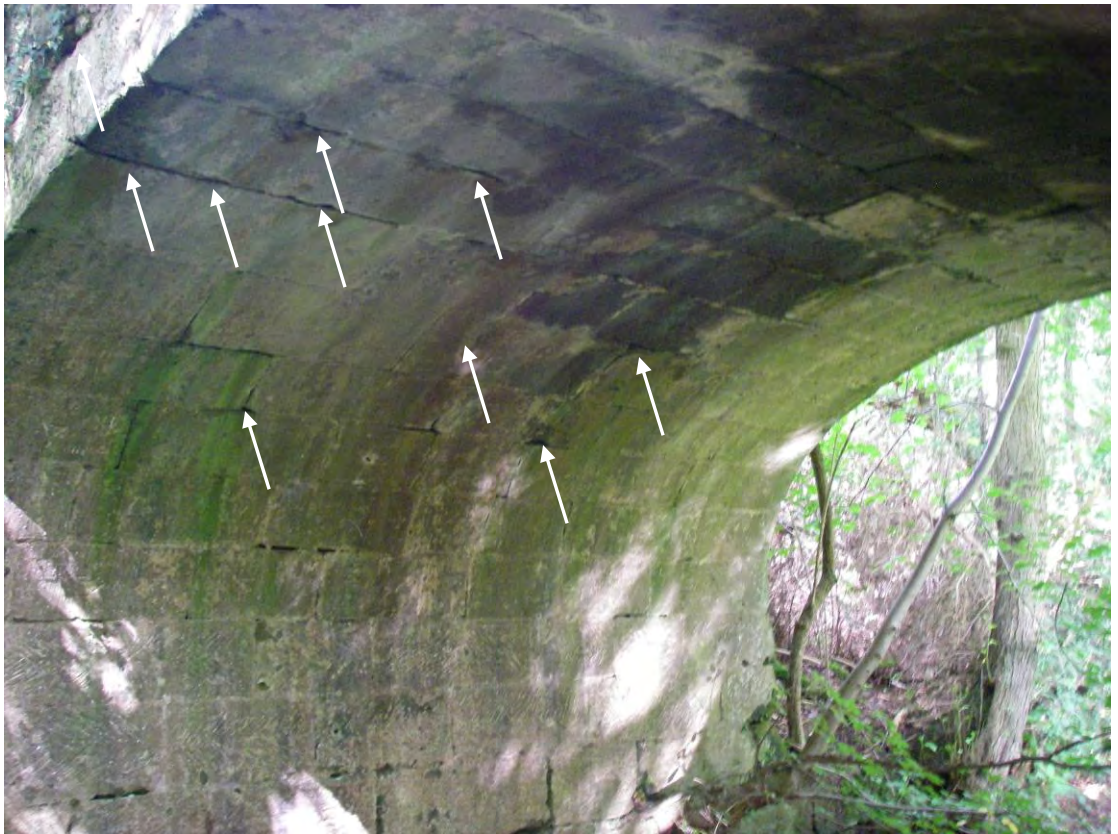
*Plate B.3: Drier areas of bridge arch showing missing mortar joints*

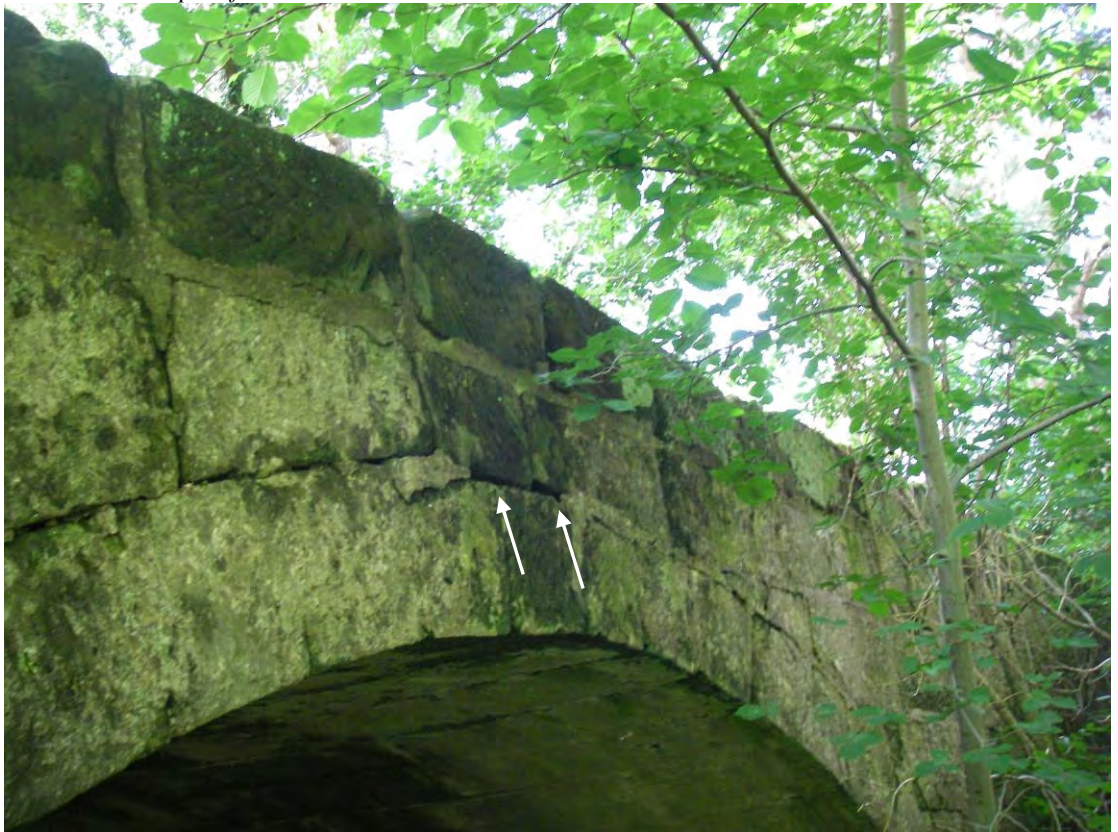
*Plate B.4: Example of crevices in elevations*

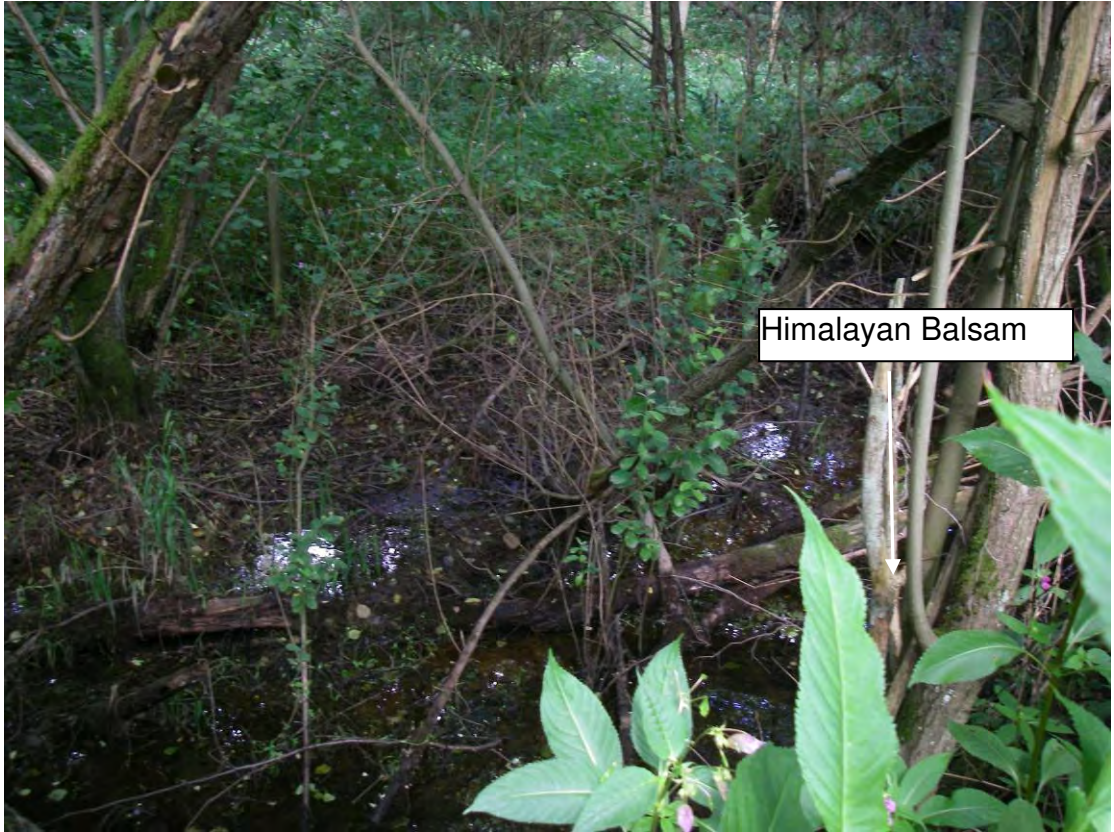
The bridge spans the disused Uttoxeter branch of the Caldon Canal, which has become heavily silted up. Tree growth, mainly alder, has encroached into the canal and caused the banks to collapse resulting in an often narrow and very shallow channel. There are deeper pools, although no where along the length surveyed was the canal deeper than approx 1m.

*Plate B.5: Typical section of adjacent disused canal channel*
