Contents			Page
Contents	l m turn al	luation '	Page
	introd	luction	
	•	Aims & scope of the survey	1
		Locks from the Severn to Droitwich 'Town'	2
	•	Nomenclature of locks	3
		Nomenclature of lock gates	4
		List of Figures	2 3 4 5 5
		List of Drawings	5
Part 1	1.1	Droitwich Canal Navigation	6

Aims and scope of survey

This Industrial Archaeological survey aims to record surviving typical detail of the lock gate structures and ground and gate paddle mechanisms on the Droitwich Barge Canal to inform the restoration process. The survey includes the unique broad lock of the Droitwich Junction Canal at Vines Park, Droitwich, which forms the connection to the navigable section of the River Salwarpe.

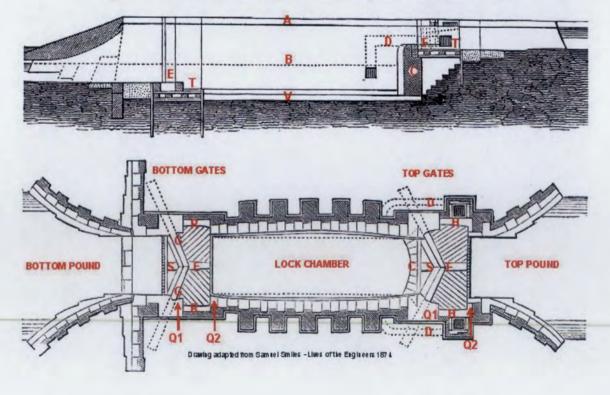
Fig 1 Section & Plan of typical river navigation or early canal lock

٧	INVERT ARCH	- stone or brick chamber bottom and foundation of chamber walls. Some early locks have a complete timber floor structure.

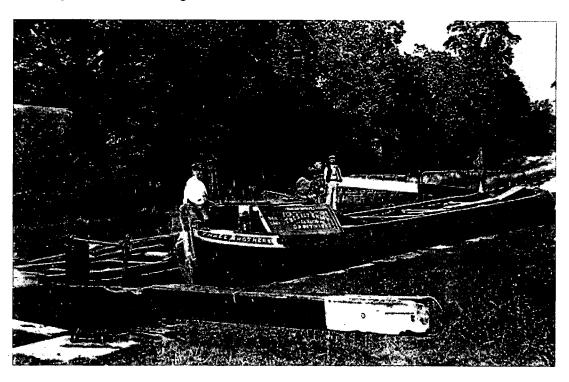
Lock 4 of Ladywood flight in 1912 - the only known photograph of the locks in use. Note particularly there is no reduction gearing on the bottom gate paddles.

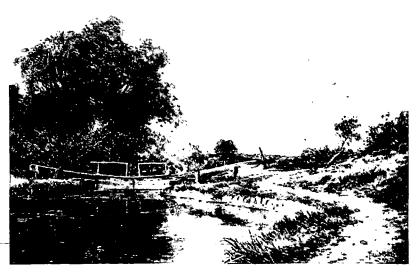
A painting of 1897 showing Lock 2 of the Droitwich Canal by David Bates is one of the few illustrations showing the top gates. Courtesy of RM Sinclair

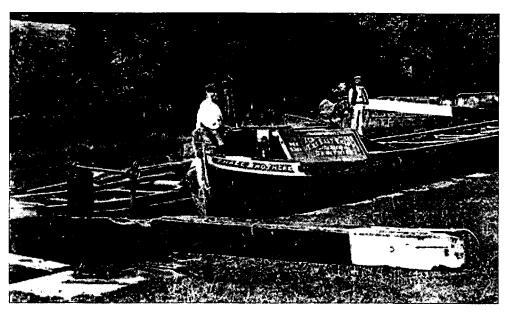
Lock 4 showing lower gate walkway and no handrails 1912 © RM Sinclair

Plank walkways were provided on forged wrought iron brackets bolted through the balance beams on upper gates above the gate bay. This seems to have been common to every lock (not Lock 2?) except the Junction Lock at Vines Park. Provision of a walkway for the lower gates seems less widespread. Locks with overbridges at the tail, (Ladywood, Porters Mill and Mildenham Mill) may not have had them. High lower gate handrails were offset on the bottom gate beams suggesting that the beams themselves were used to cross the gates. The one surviving old photograph of Lock 4 clearly shows no lower gate handrails in place, though a walkway is fitted below the gates.

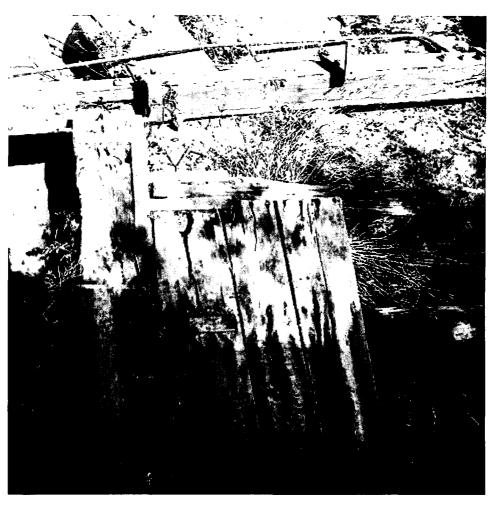
Top gate lifted out for replacement showing iron plates (straps) and walkway brackets fixed to the beam with low handrail above.

An early Staffordshire & Worcestershire drawing survives at Staffordshire Record Office (No TP598). This identifies and illustrates all the iron strapwork components (plates) for replacement gates in 1830.

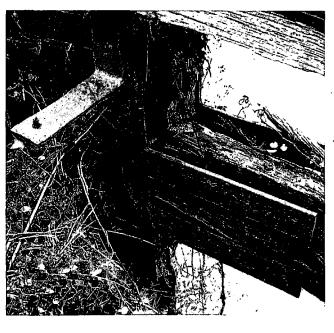
Collar plates still in situ on Lock 7 top gate © David McDougall 2007

The collar strap is a distinctive and functional feature of these large gates. In addition to the extra bracing obtained by this double strap, the 'L' feature holds together the quoin post over the collar hole and helps to prevent splitting and shrinkage cracking of the tenon joint above. These plates are recessed into the bars, planking and quoin post each side to lie flush with the timber surface.

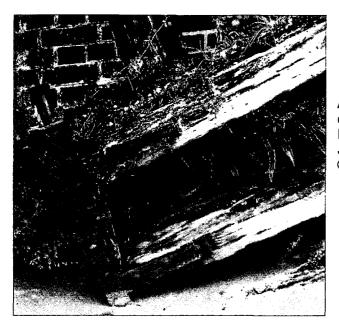
Long and short 'T' plates are used for the gate bar to 'quoin' and mitre post mortice and tenon joints. Long 'T's have a 4 pin fixing through the bars, short 'T's having only 3 pins on this arm. Iron stock size is 3 inches wide by ½ inch (75mm x 12.5mm) thickness. The right angle arm joint is fire-welded in the wrought iron. Pins are countersunk and hot riveted through. These 'T' plates are recessed into the planking, quoin post and mitre post to lie flush with the woodwork. The upright part of the 'T' is set further towards the hollow quoin and mitre than is the case with the collar and head plates as they are shorter.

A pair of short 'T' strap assemblies on collapsed gate at Mildenham Mill Lock 6
January 2007
© David McDougall

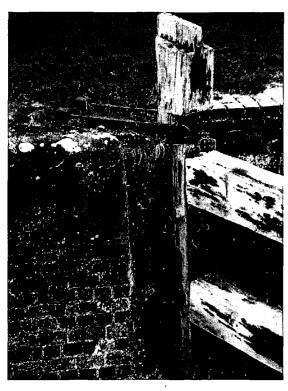
Collar forging at Mildenham Mill Lock 6 retaining replacement top gate.

Collar forgings are from 3 inches (75mm) width by $1\frac{1}{4}$ (32mm) thick wrought iron, flat stock, square-edged with no change of section. The extra long horns are slot punched near the end to take a tapered cotter or wedge plate. Slots are $2\frac{1}{4}$ inches (57mm) long x $\frac{3}{4}$ inch (20 mm) wide, 1 inch (25mm) from the ends of the horns.

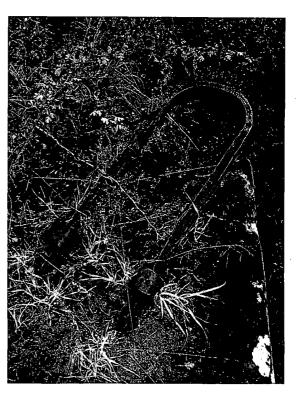
Collar forging in situ at Hawford Lock 7. Two of the staples have sheared off. © David McDougall

Staples for the collar forging are double each side. Many of these have broken away. Molten lead holds the iron staples into the stonework of the quoin coping.

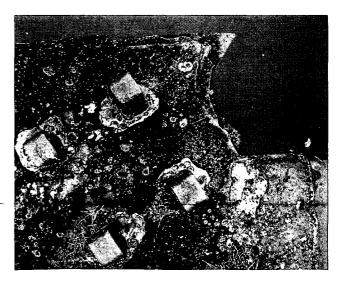
Tie rods (tie bars)

Top gate Lock 4 in 1965. Tie rod below top bar comes through the mitre post into a square hole for the nut. Tie rod is hidden in a groove in the bottom of the top bar. © RM Sinclair

Further tie rods are set just above the bottom gate bars (sill bars) on top gates, and top, middle and bottom bars on lower lock gates.

Correspondence of the nut recesses in a pair of gates is likely to provide a leakage point under water pressure. Wooden plugs were probably fitted to reduce this when the gates were new.

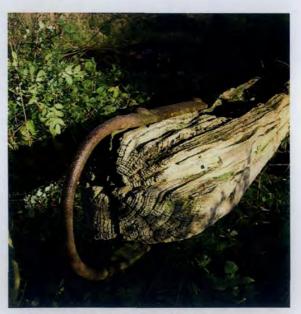
The Lock 7 beam is considerably decayed but measured up at 11 x 12 inches (280 x 305mm) on the outer end shaped half round under the handhold forging. The beam tapers in thickness to the mitre post after the curve of the offset (crank) running at 11 inches (280mm) wide over the quoin post down to 10¼ inches (260mm) under the bolted T straps.

Top gate balance beam at Lock 7 has a curve offsetting the beam by 12 inches (300mm) at the end. The handhold is forged from D section wrought iron and riveted through the beam depth.

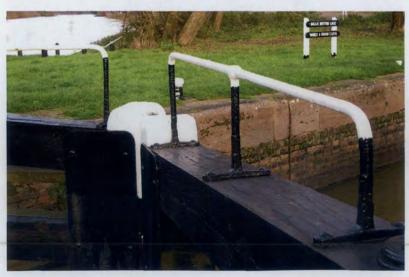
Diglis Locks,
Worcester.
Worcester &
Birmingham made
handrail in wrought iron
© David McDougall

Three basic iron handrail designs have been identified on the locks. Each has the appearance of Worcester & Birmingham manufacture as design features match those on locks at Worcester Diglis Basin.

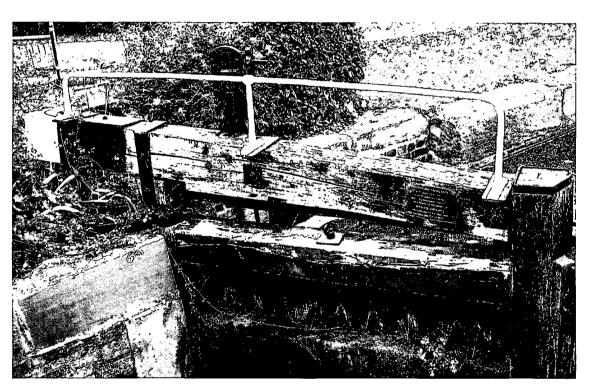
Lock 1 at Ladywood has recycled handrails from upper gates fitted on the cranked bottom gate beams.

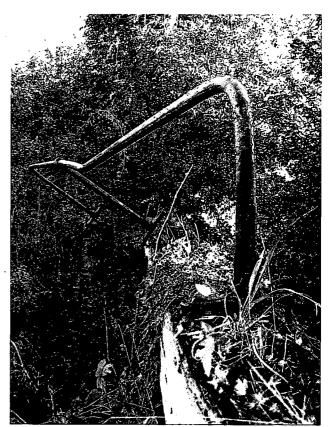
Lock 7 surveyed handrail on top gate

Certain photographs show additional strapping used to secure this handrail at the mitre post suggesting the coach screw fixing was subject to failure due to wood rot weakening of the screws. This may be the major reason for the surviving handrail being severely bent in situ.

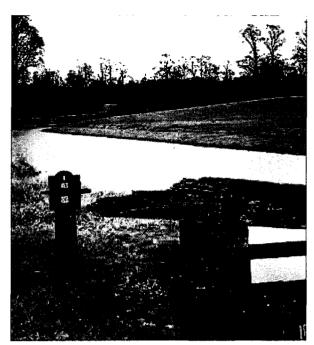
1939 record photograph shows rack stripped from this stand at Lock 4

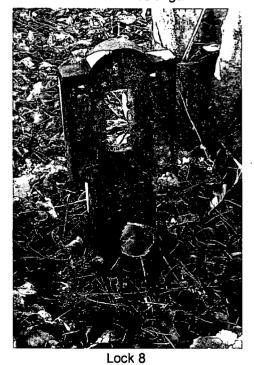
Original Worcester & Birmingham Canal type cast iron stands are in situ on Locks 7 & 8 stripped of their gearing and racks but are capable of refurbishment.

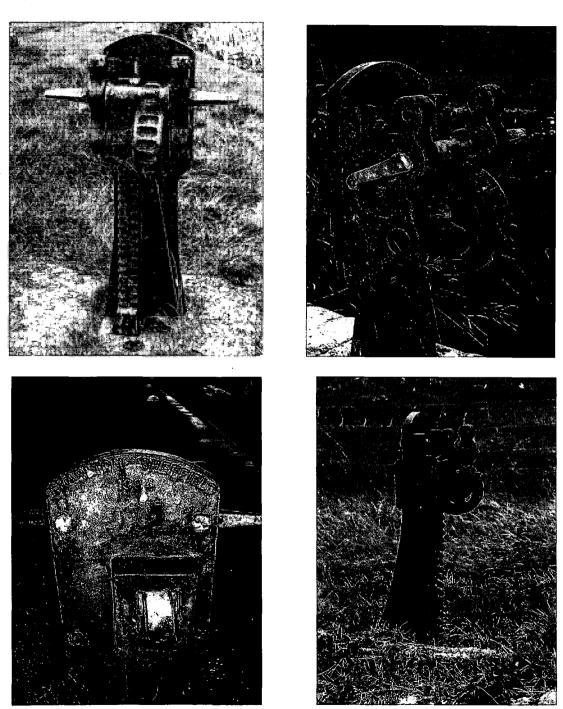
1.34 Replacement Paddle Gear

Replacement ground paddle gear on locks 1 to 4 of the Barge Canal are BCN component pattern with reduction gearing fitted with no catches. Castings from Charlton of Sheffield.

Locks restored on the Droitwich have been fitted with standardised Shropshire Union / BCN castings which take a reduction set of gears usually found on bottom gates. These were cast by Charlton of Sheffield and fitted in 1984. Gearing gives a 5:18 reduction (1:3.6). Double taper spindles of 1 inch square taper with 5 teeth are fitted.

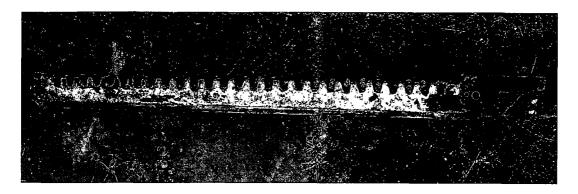
Broken rack at Droitwich Canal Trust Depot of deep tooth form with Worcester & Birmingham Canal rib on back.

No original Droitwich rack has so far been located for measurement, though a broken rack at Droitwich Canal Trust's Depot appears to be of the correct Worcester & Birmingham Canal type and length.

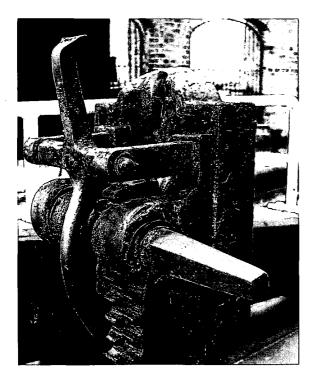
Above: Right and Left hand forged catch fittings at Diglis Locks

The Worcester & Birmingham Canal catch forging is a cruciform wrought iron fire-welded component which was made either left hand or right hand by forming the curved handle and tapered 'spade' end on alternate faces of the component. These parts were handed as it was important that the catch handle was nearest the side of the rack closest to the spindle on which the loose windlass handle being used was fitted.

The modern replacement parts are castings rather than forgings and have Part No 5037 cast on them. These seem only to be made as right hand components making them slightly less easy to use.

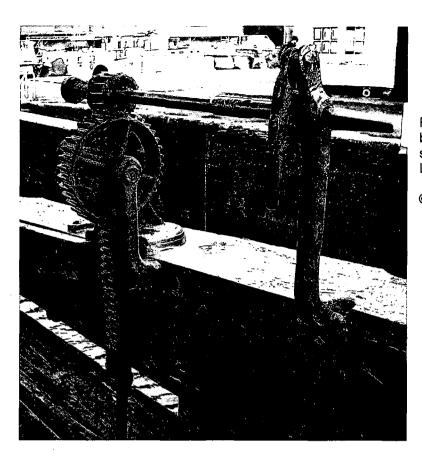
Forged iron support bracket for extension spindle fitted on Barge Locks at Diglis Worcester

The forged brackets are standard fitments on the locks of the Worcester & Birmingham Canal and are usually found in conjunction with reduction gearing as here on the Diglis Basin Barge Locks.

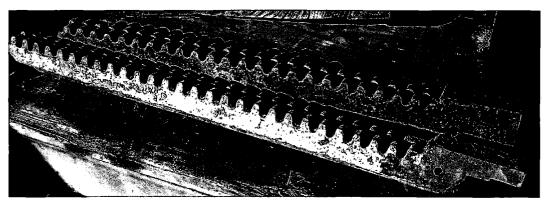
Teeth on this rack are 1 inch (25mm) pitch, double row offset of ⁷/₈ inch (22mm) width. Tooth form is deeper than standard racks of BCN and Shropshire Union Canal origin now widely fitted throughout the Midlands canal network and supplied from Northwich and Bradley BW workshops.

Broken Rack of Worcester & Birmingham Canal origin compared with a similar standard rack behind. The standard rack is a short version.

The square socket end is of the correct dimensions to fit the paddle bar or rod termination measured in situ at Mildenham Mill Lock (see Drawing No 14), where the gates have decayed leaving the paddle rod standing. Elsewhere paddle rods have snapped or bent as the gates collapsed. Racks may be found in the silt of locks 7 and 8 when they are cleared.

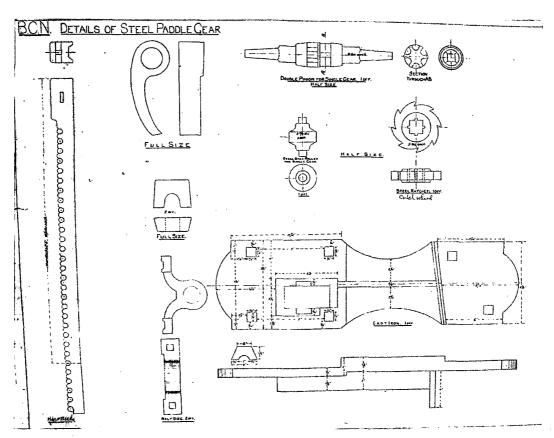
Although this is described as steel paddle gear virtually all components shown are cast iron. This paddle gear utilises standard short BCN racks as shown on the drawing with grooved and chamfered backs. Tooth pitch is 1 inch (25mm), twin offset rows with 25 teeth per rack are used on the Droitwich assemblies. Gear reduction obtained is 5:18 or 1:3.6.

BCN cast iron paddle gear for gates © The Waterways Archive BW165/18/8/12

As the Droitwich locks are not in use no extension spindles have been fitted nor are support brackets available for them. Two worn out Shropshire Union / BCN assemblies are in Droitwich Depot as potential patterns. These may not give correct fit and would not be as appropriate as Worcester & Birmingham

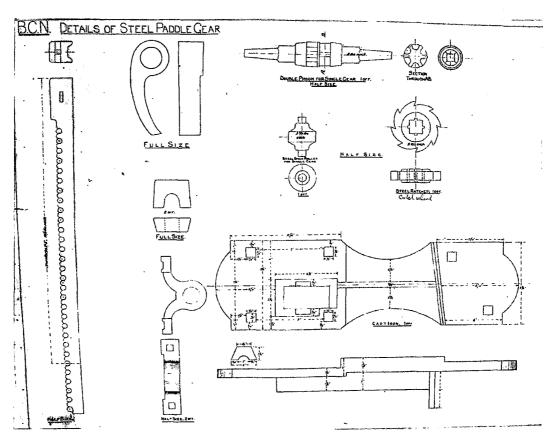
Although this is described as steel paddle gear virtually all components shown are cast iron. This paddle gear utilises standard short BCN racks as shown on the drawing with grooved and chamfered backs. Tooth pitch is 1 inch (25mm), twin offset rows with 25 teeth per rack are used on the Droitwich assemblies. Gear reduction obtained is 5:18 or 1:3.6.

BCN cast iron paddle gear for gates © The Waterways Archive BW165/18/8/12

As the Droitwich locks are not in use no extension spindles have been fitted nor are support brackets available for them. Two worn out Shropshire Union / BCN assemblies are in Droitwich Depot as potential patterns. These may not give correct fit and would not be as appropriate as Worcester & Birmingham

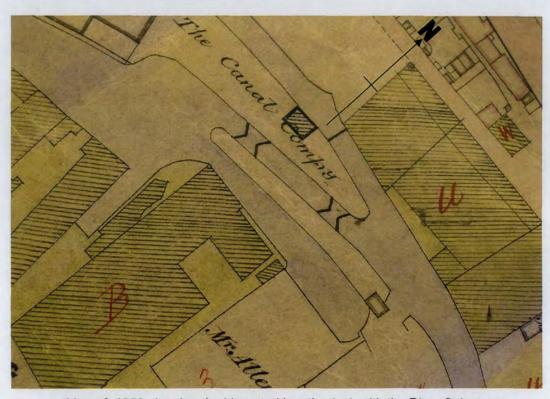
Map of 1858 showing double-gated junction lock with the River Salwarpe alongside the original Droitwich Basin. From survey of 1854 by Webb & Buck.

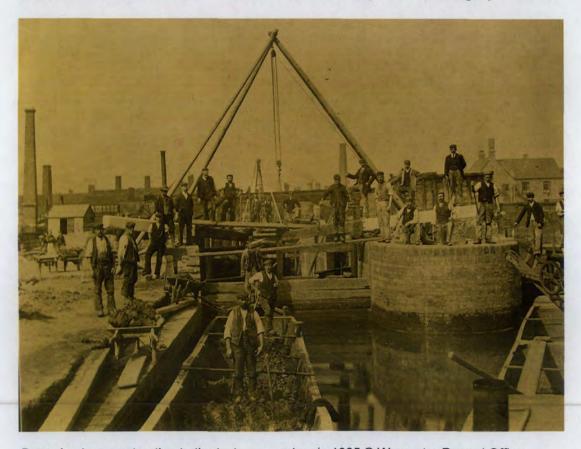
Barge Lock reconstruction to the lock approaches in 1905 © Worcester Record Office

Another 3 feet (0.915m) of brickwork was added to the towpath walls, lock approach walls, river pier and the cill of the river sluice along with its side walls in 1905 when the Vines Bridge was also renewed. At this time the adjacent river embankments were re-laid 3 feet higher with clay puddle to assist with floodwater flow. This work is underway in the photograph below.

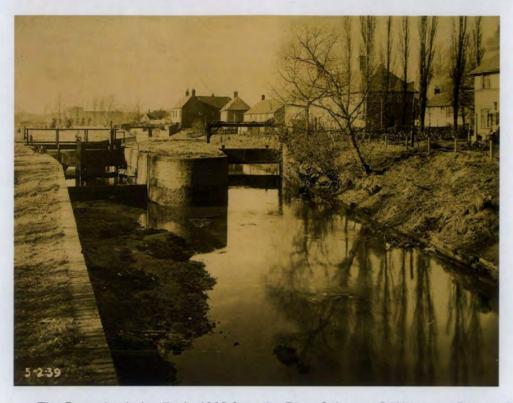
The Barge Lock derelict in 1939 from the River Salwarpe © Worcester Record Office

By 1939 the canal basins were choked with silt, the lock was in complete disrepair and unusable with the gates decayed, paddle gear partly removed and the chamber full of silt brought in by the river floods. The moveable river weir guillotine gate seems, however, to have in usable order at this time.

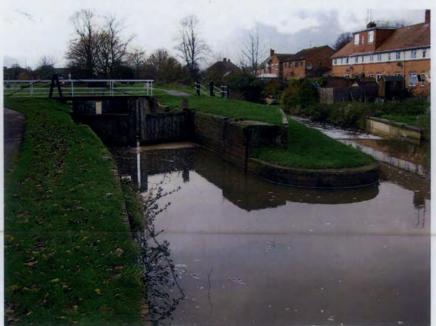
The Barge Lock from the Salwarpe 2007 © David McDougall

Modification and lowering work on the adjacent weir has removed much of the rounded pier brickwork and copings back to the cast iron stop plank groove on the northern side of the lock approach.

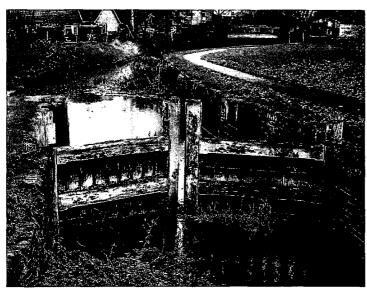
Outward facing gates to the Salwarpe at the east end of the lock 2007

New gates have no ironwork at joints, paddle gear or balance beams fitted. Round section tie rods alone hold the mortice and tenons together. The gates have sagged out of shape due to lack of bracing and balance beams. Decay at the joints is evident.

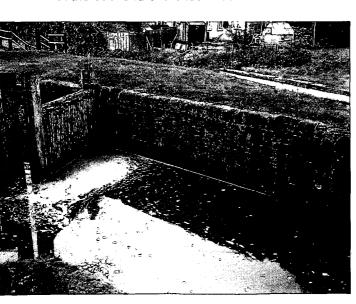
Outward facing gates at the west end of the lock 2007

Paddle channels in the brickwork of the northern east end gate recesses

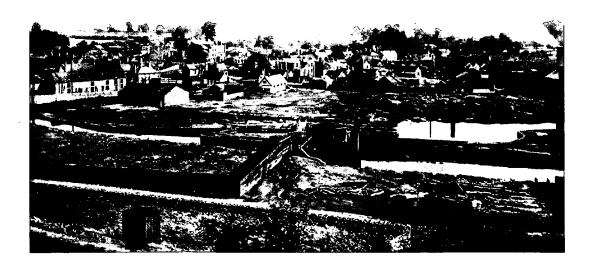
The earliest scenic view of Droitwich clearly shows the gate form and balance beam provision of the flood and river junction lock prior to the 1903 rebuilding work. Essential features deduced from this are shown in Drawing 8a. This represents only the eastern gates and quoins on the moveable weir side of the lock nearest the Salwarpe. On this side were sited the two eastern paddles. The inner gate pair is fully sheeted up to the balance beam to give flood protection up to the lock coping level. The outer gate pair is of weir type as flooding would push this open anyway. Balance beams are clearly of 'piggy back' type bolted on top of the upper gate bar. This gives a good fix for the paddle jackhead without requiring large cutaways in the lock coping. Balance beams are long but relatively lightweight. Lock gates have no walkways or handrails fitted. The central swing bridge over the lock provides the only access required for operating the gates and paddles. Paddles are arranged on this side for convenience of operation of the moveable weir structure adjacent. This was a largely timber structure as the photograph shows.

River Salwarpe and Junction Lock from Dodderhill prior to 1903 from postcard published by Valentine's from David McDougall collection

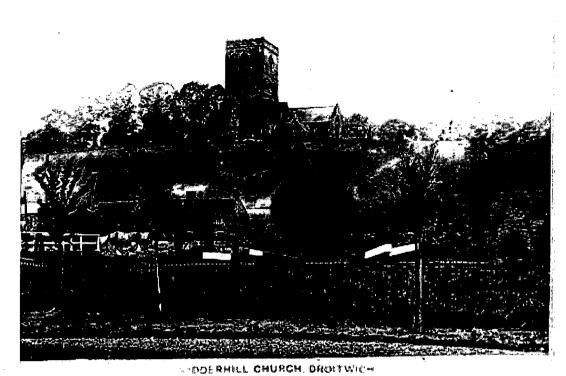
Post 1903 view of the lock showing new balance beams, and swing bridge to the left © RM Sinclair

The 1903 reconstruction work to the lock approaches was arranged in conjunction with partial re-gating and repairs. New 'conventional' balance beams of larger section but shorter length were fitted with new paddle stands to the inner pair of gates now no longer fully sheeted. Flooding was now fully controlled by a new moveable weir and raised walls to the lock and clay puddle to the Salwarpe channel. Gates shown in Drawing 8b are the new arrangement which were in situ at abandonment by which time the older outer gates had disintegrated.

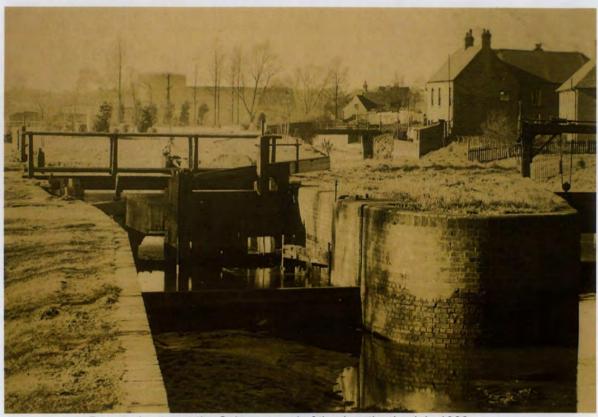
Decayed gates at the Salwarpe end of the Junction Lock in 1939

No original gate ironwork remains to be measured or recorded. Most of this was standard forged wrought iron work as samples recorded on lock 7 – see sections 1.22 and 1.23. Gates fitted here had some non-standard detailing in particular the outer gates to the east were fitted with head plates ('F' straps) on both top and second bars at quoin post and mitre post mortices. This would produce a stiffer than standard gate construction. It is possible, however, that this was part of an economy repair undertaken to extend the life of these gates when the new beams were fitted. These outer gates had virtually disintegrated by 1939, whereas the inner gates were largely intact. (See Drawing No 8b.)

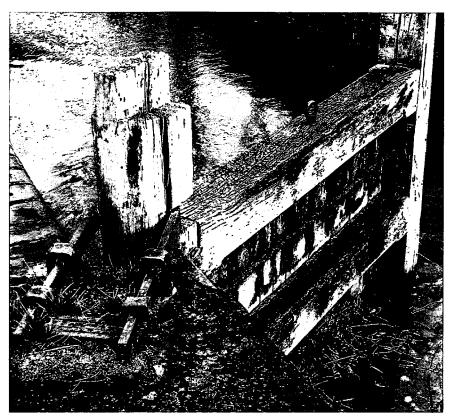
Collars are wedged behind the four staples which secure the forging to the quoin stone

The double gate recesses are fitted with 8 cast iron quoins similar to those on the top gates on the remainder of the Barge Canal. Only 4 gates in total are hung in these. The long collars slot through sets of 4 'staples' leaded into the quoin coping stone above the quoin casting. Some of these staples are missing, removed or broken.

Collars fitted to the gates in situ are forged from 3 inch x 1 inch (75mm x 25mm) square edged stock steel. Inner bend diameter round the quoin post is 10½ inches (260mm). There is no forged or cut change of section. Horns are slotted for cotters. Punched or drilled slots are 4 inches long x 1 inch wide (102mm x 25mm) 2½ inches (57mm) from the end of the horns.

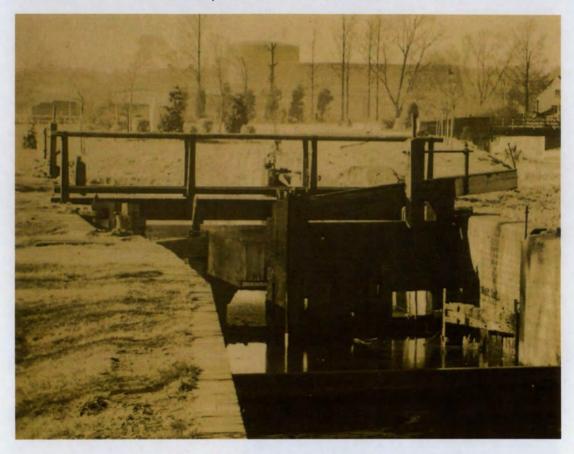
Enlargement of 1939 view of derelict Barge Lock to show paddle gear © Worcester Record Office

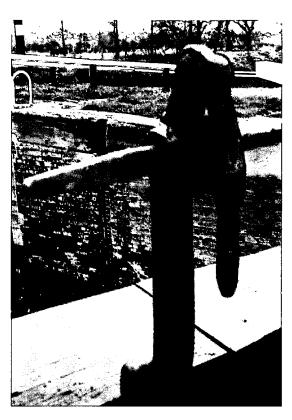
Worcester & Birmingham catch on Diglis River Lock 1 © David McDougall 2007

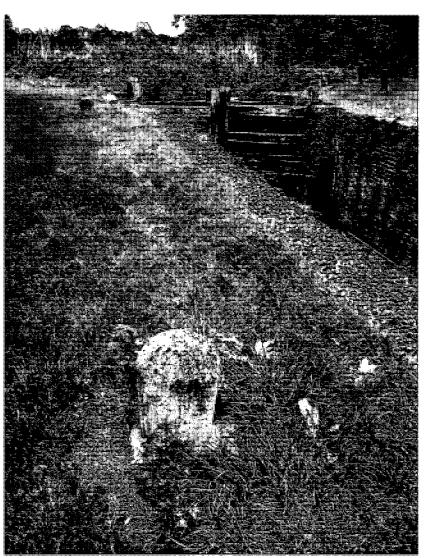
Lock bollards are fitted at many of the locks restored in the 1980s. These are concrete 'bulb' shaped castings from a mould used on the Basingstoke Canal.

Concrete bollards at Mildenham Mill Lock © David McDougall 2007

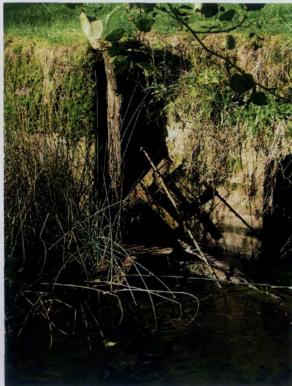
In particular, it has not been possible to record details of ground or gate paddles or the bars (paddle rods) to operate them. This is due to floodwater at the time of completion of this survey.

Cruciform walkway fittings not measured in Lock 7 above and top gate tie bar in Lock 8 require recording when clearance is undertaken

The opportunity to record components in detail should be taken when work on clearance is undertaken. It is suggested that further detail should be added to this document.
